POST OCCUPANCY EVALUATION

AMESBURY SCHOOL CHURTON PARK, WELLINGTON

May 2015

Date: April 2015
Reference: 1-46083.00
Status: Final v15

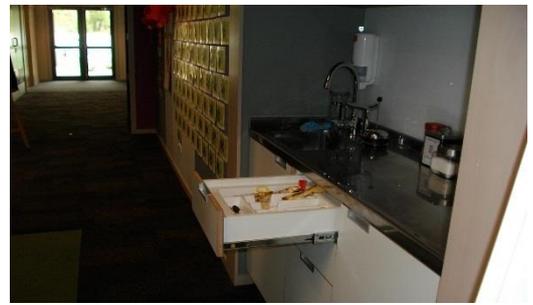
Figure 6

- Kitchen facilities within reception are on the main circulation route through the building - they are not recessed and are not suitable for all users as highlighted in the accessibility report. Potential hazard. See Figure 6.

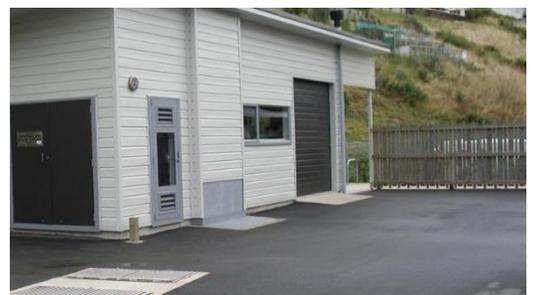
Figure 9

- No gates to secure the maintenance area to prevent access to service pits and equipment. See Figure 9.
- Main playing field area is not visible from the Staff Space despite entirely glazed walls to north and south (fields are east of this room). From the south deck the central courtyard (between hubs) is overlooked.
- Principal chose to relocate to the shared office with other staff to allow better oversight and connection with/accessibility to students.
- Smoke check doors (no smoke seals evident) with closers are permanently fixed open.

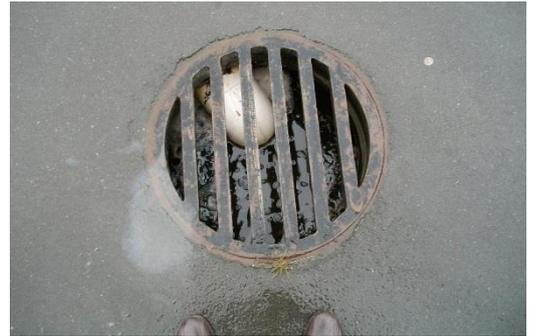
Figure 11

- Rainwater grate with excessively wide gaps at the school entrance area and playground. Possible trip hazard. See Figure 11.
- Wet areas have been incorporated into circulation space. Possible slip hazard.

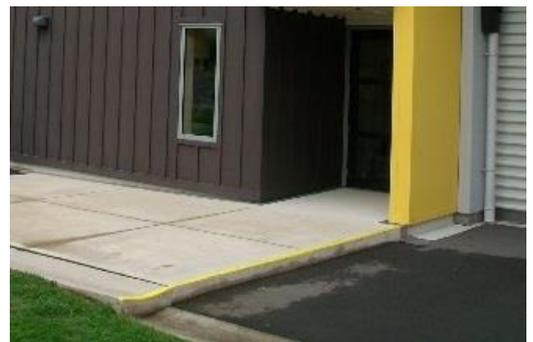
Figure 12

- Concrete step (which appears to be a post-design addition to mitigate deficiencies in accessibility) adjacent to the rear exit. Potential trip hazard, particularly to sight impaired users. See Figure 12.

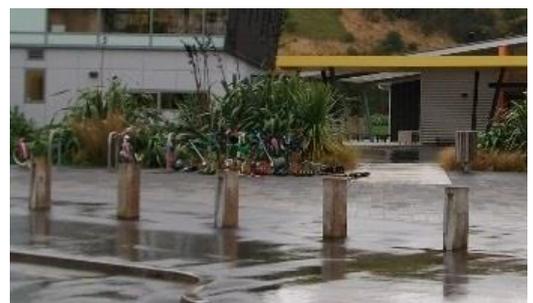
Figure 13

- Recessed timber bollard lights around car park have been permanently shut off as they were identified as a nuisance to residents at neighbouring properties. Possible safety and security hazard. See Figure 13.

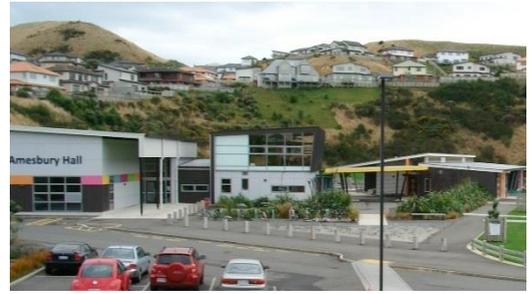
Figure 15

- Reception has no visibility to the front of the school with no way of monitoring visitors unless they report voluntarily.
- No fencing to the road frontage boundary/entrance and between playing fields and car park. See Figure 15.

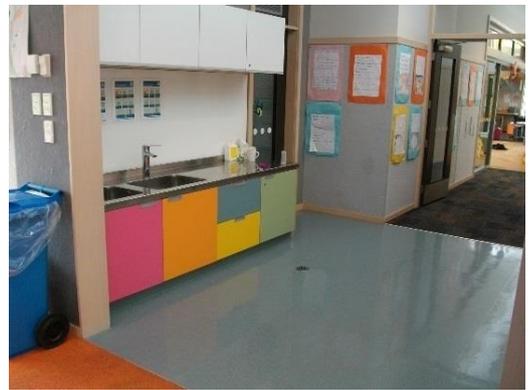
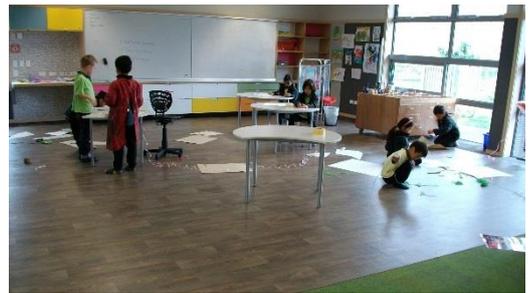
- Wet areas poorly located - too far from the learning area. School had worked around the problem by installing their own waterproof vinyl (loose laid) to one teaching space, becoming the dedicated area for related tasks. See Figure 22 and Figure 23.

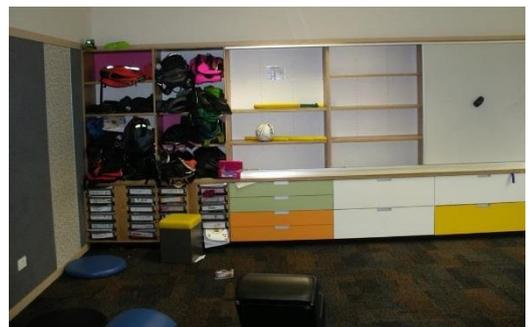
Figure 24

- Lack of storage. Insufficient provision generally throughout school, and in the teaching spaces specifically. See Figure 24.
- High level windows in learning spaces, corridors and access ways are operated automatically through carbon dioxide sensors, however we understand that the control system may not have been programmed correctly. Varying carbon dioxide levels cause the windows to operate erratically, operation is too loud and is disruptive to teaching/learning environment so has been turned off. Adjustment required

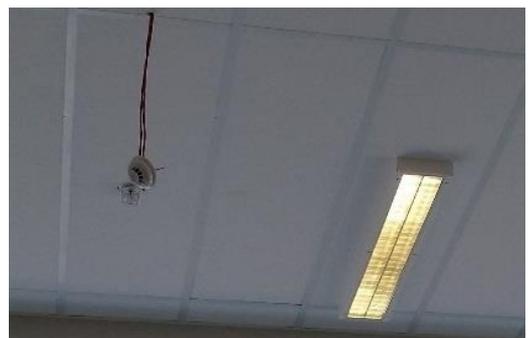
Figure 25

- The smoke detectors and lights within the multipurpose hall space require protective guards to be fitted and the detectors secured properly to prevent damage. See Figure 25.

- Insufficient protection to light fittings and smoke alarms on Multipurpose Hall Space ceiling - evident due to one damaged smoke alarm hanging from wiring.

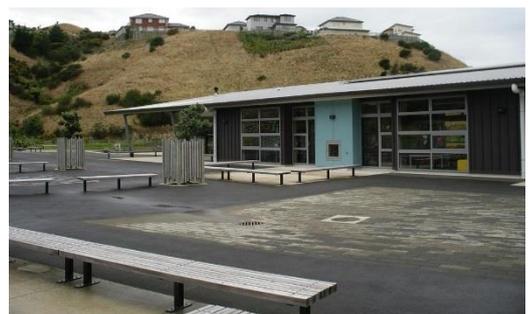
Figure 26

- Times when covered walkways and canopies are ineffective due to combination of wind and rain.
- Minimal (insufficient) seating was observed to the covered outdoor learning areas. Outdoor seating was provided mainly in exposed outdoor areas. See Figure 26.

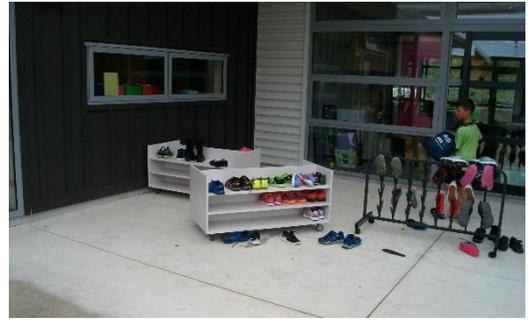
Figure 27

- The covered outdoor learning spaces are generally used to shelter mobile storage cabinets for students' shoes and other equipment. See Figure 27.
- No drainage laid adjacent to drinking fountains, and mildew/moss was observed to be beginning to grow on pavement around fountains.

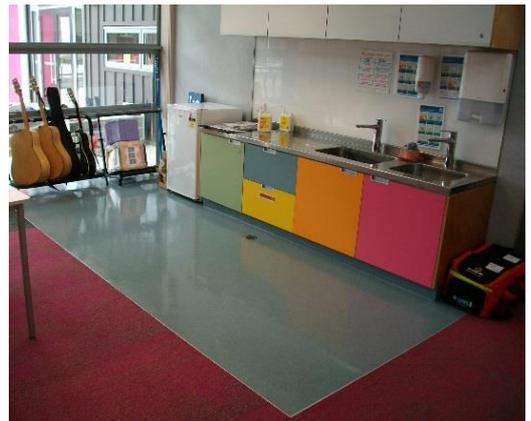
Figure 29

- Wet areas are insufficient - too much carpet, not enough vinyl. Generally one wet area for two class groups is less than half the MoE requirements. See Figure 29.

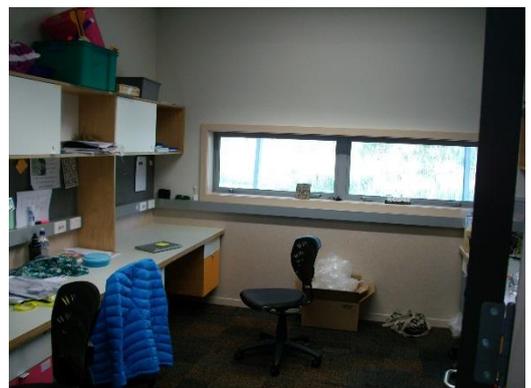
- No gym change area facilities provided near/in Multipurpose Hall Space.
- Teacher Work Spaces lack visual connection to student areas. Staff report heat issues due to solar gain. It was observed that teacher workspaces were fairly large and had shelving and work space for each teacher. See Figure 30

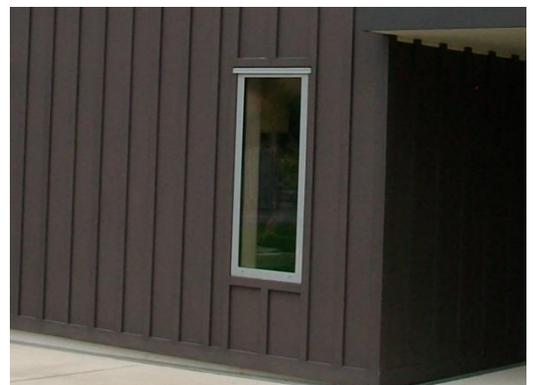
Figure 33

- Windows without external sills allow water to run down the face of the external cladding resulting in premature failure of the fabric and increasing operational costs. See Figure 33.

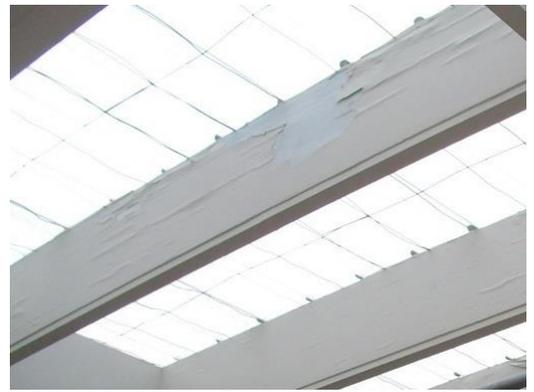
Figure 34

- Failing paintwork to the rafters of the covered outdoor areas on Block A. The cause appears to be water penetration through the UPVC roofing fixings and potential poor finish quality of paintwork. See Figure 34.

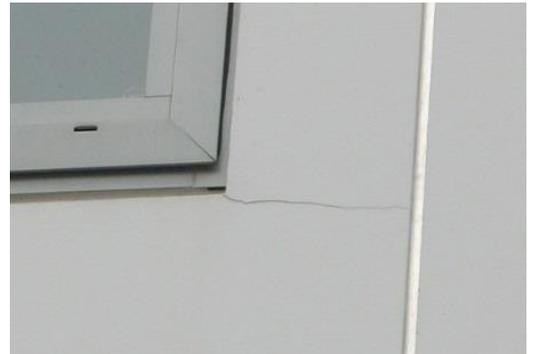
Figure 35

- Minor damage to external cladding on panels around openings - e.g. that of Figure 35.
- Cost to maintain infrastructure with grants for 150 students means 80% of the operations grant is spent on property maintenance costs. School must find the shortfall to maintain the property (due in part to the budget having to maintain infrastructure for a school of 400 students at present, but only funded for the current number attending). There is concern about maintenance to comply with warranties (i.e. building wash). Grounds maintenance also very expensive.

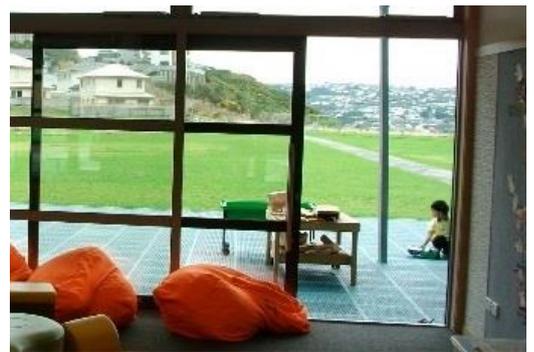
Figure 36

- The external sliding doors are already starting to fail. The runners and guides are prematurely failing or going out of adjustment making them difficult for students to open. Door maintenance will become increasingly expensive. Door type in Figure 36.

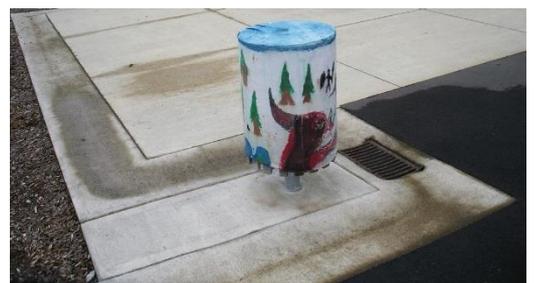
Figure 37

- Rubbish provided are not in use due to school take home rubbish policy, so bins have been sealed or removed. See Figure 37.

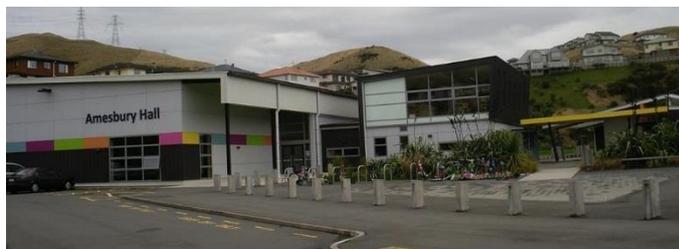
At present there is no physical barrier to restrict student access to the road.

Figure 39 – Lack of front barrier fence.

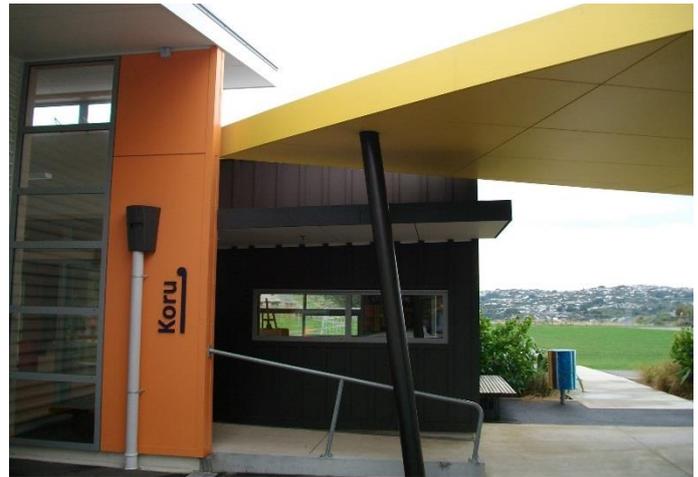
Overly complex and potentially higher risk designs, such as inward sloping roof areas and exposed timber cladding, means that the structures are more vulnerable to water penetration and means that more frequent monitoring of the building fabric is required.

Figure 41 - Overly complex designs.
