# POST OCCUPANCY EVALUATION

## HOBSONVILLE POINT SECONDARY SCHOOL HOBSONVILLE POINT, AUCKLAND

**June 2015**

Date: June 2015  
Reference: 1-46083.00  
Status: Ver 7

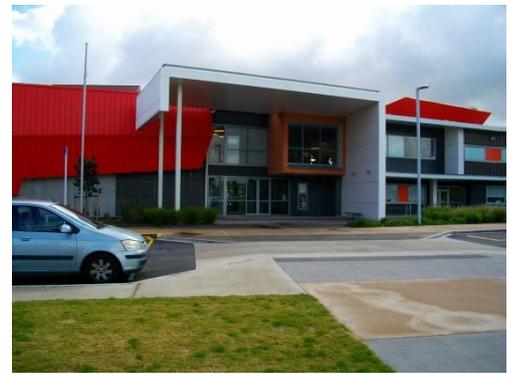
Figure 10

- Access to the vehicle drop off and visitor car park crosses through the pedestrian pathway to the main entrance. See Figure 10.
- The drop off zone vehicle access has been identified by the school as a potential safety issue when 1350 students attend the school. Discussions have commenced with Auckland transport in relation to the management of this safety risk.

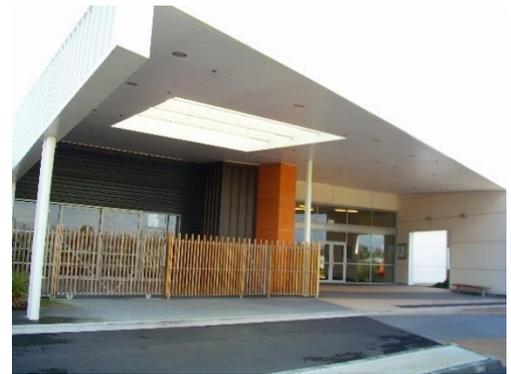
Figure 11

- Visitors have trouble locating the main entrance and reception due to poor signage and the competing, more visually prominent secondary entrance also located on the road front. See Figure 11.

- The reception is not easily located by visitors due to a lack of clear signs and the competing more visually prominent secondary entrance located on the upper level in the middle of the building. Way finding signage should be installed to direct visitors to reception.

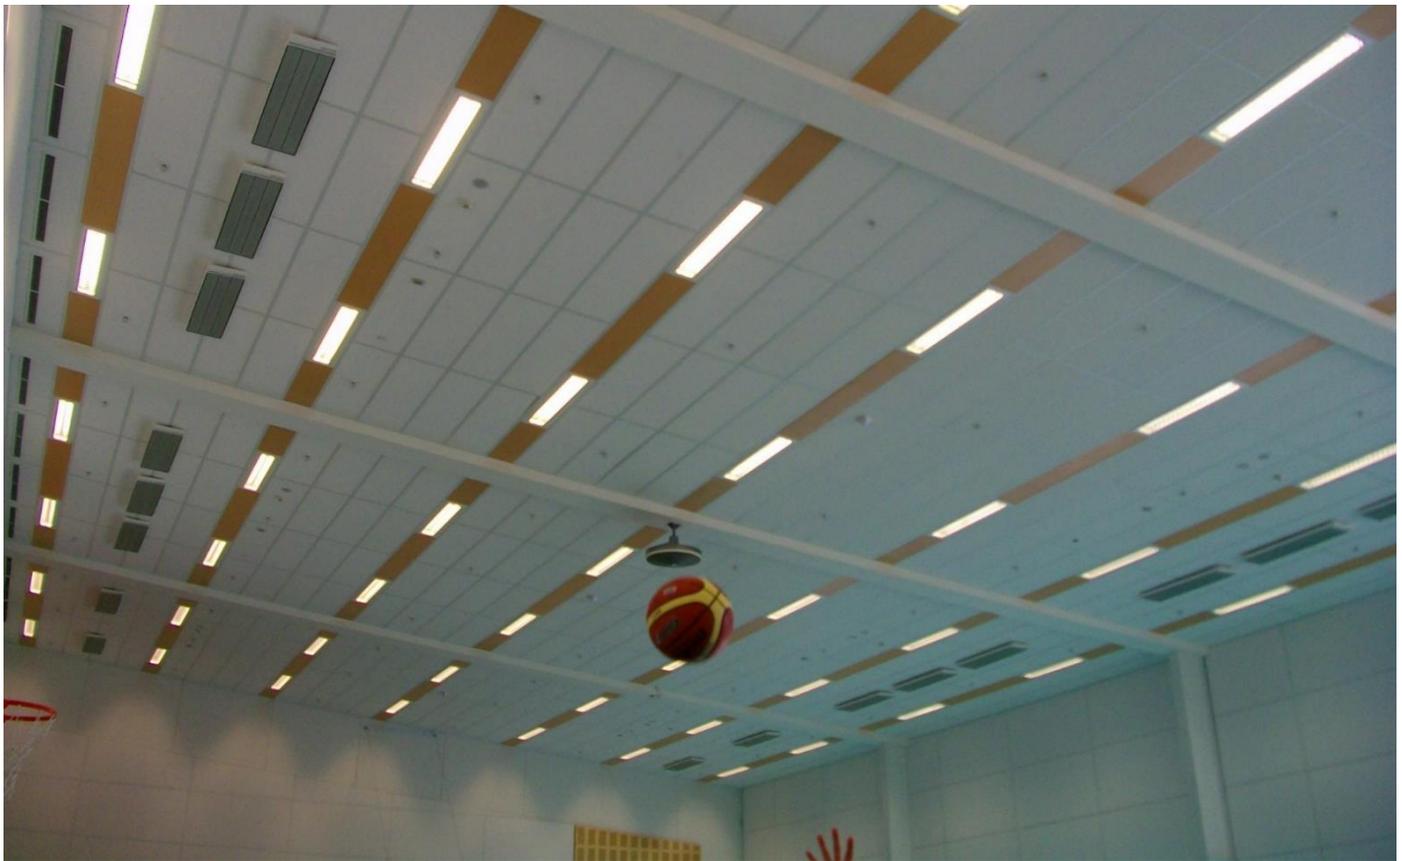
- Gymnasium radiant heaters and light fittings have no impact protection. The suspended ceiling is inappropriate for this location with tiles constantly dislodged.

Figure 22 - Main gymnasium ceiling

- The ceiling tile system, light fittings and ceiling mounted heaters to the gymnasium are not protected from impact damage. Protective cages should be installed to all fixtures and the ceiling tiles replaced with an impact resistant ceiling.

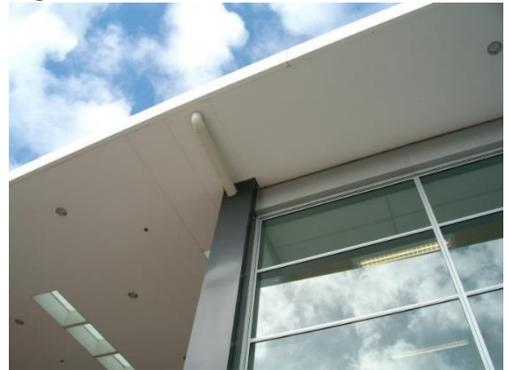
- Balconies and membrane roofing systems are located over internal spaces creating a risk of water penetration. See Figure 38
- External cladding panels of wood fibre resin are presenting a significant number of broken corners, exposed external corners are unprotected.

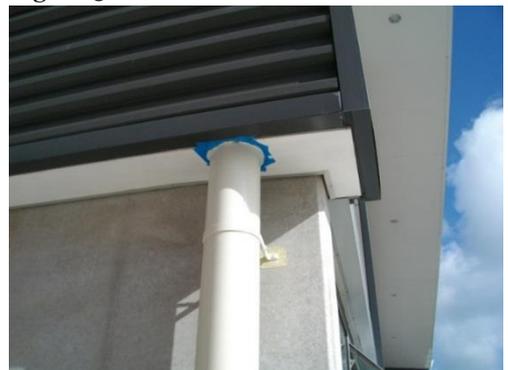
- Roofing has concealed fascia and gutters and internal rainwater downpipes resulting in access issues for maintenance. See Figure 39
- Roof leaks have been constant, the reported number of leaks has reduced from 20 leaks per heavy rainfall at occupation, down to 11 leaks per heavy rainfall.

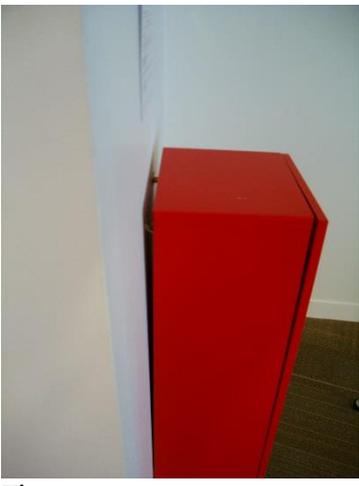
- Fire extinguishers cupboards are surface wall mounted a number are already coming away from the walls. See Figure 41
- Student locker doors are easily removed and damaged constantly requiring repair.
