# POST OCCUPANCY EVALUATION

## PAPAMOA COLLEGE PAPAMOA, TAURANGA

Date: June 2016  
Reference: 1-46083.00  
Status: FINAL

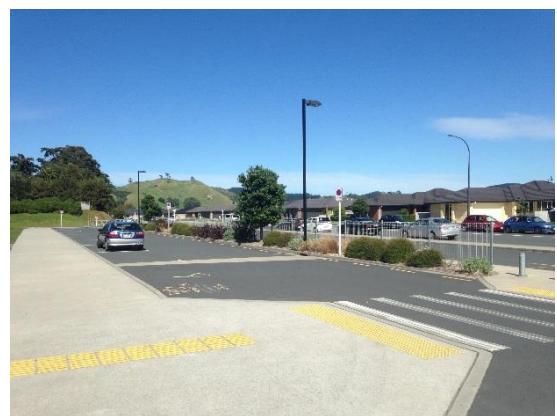
Figure 3

- There is a designated drop off area to the front of the College (along the road side directly west). This is separated from the adjacent road with pavement and railings, and reportedly works well according to staff. See Figure 3.

- Users feel that the pedestrian connections from the drop off zone, car parking areas and bike stores to the College grounds and entrances are excellent. The drop-off zone, including its road entrances, is separated from the car parking areas. See Figure 3.

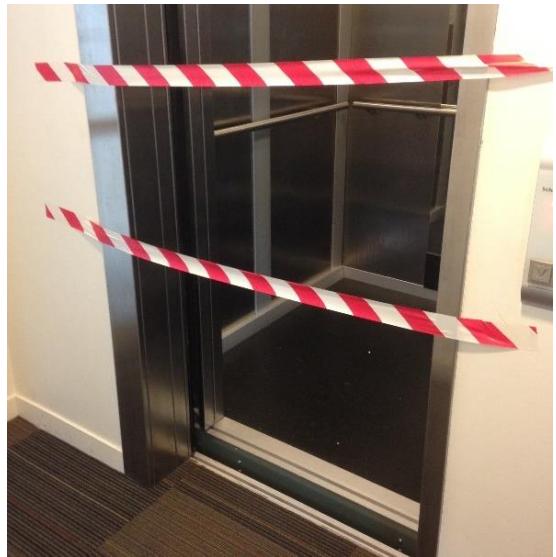
- The Principal reports that the lifts are problematic, as they often fail to operate and their maintenance is costly. See Figure 6 of a non-operational lift identified during the survey. As such the use of the lifts has been limited to disabled students and staff.

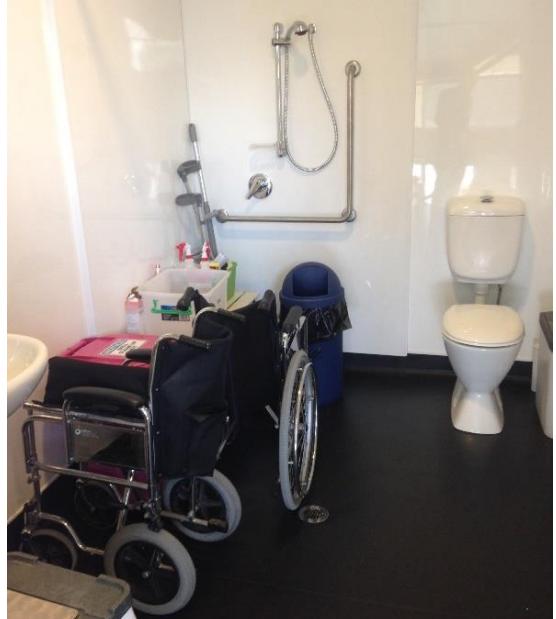
Figure 7

- Staff report that due to insufficient allowance for storage within the design, some unused accessible bathrooms are being used for storage of equipment. See Figure 7.

- There are no emergency call buttons within the accessible toilets, and oversight into these spaces is minimal for passers-by. See Figure 7.
- Whilst not a requirement of the MoE guidelines at the time, there are no power outlets within the accessible bathrooms to allow for the potential need for hoist facilities in the future.

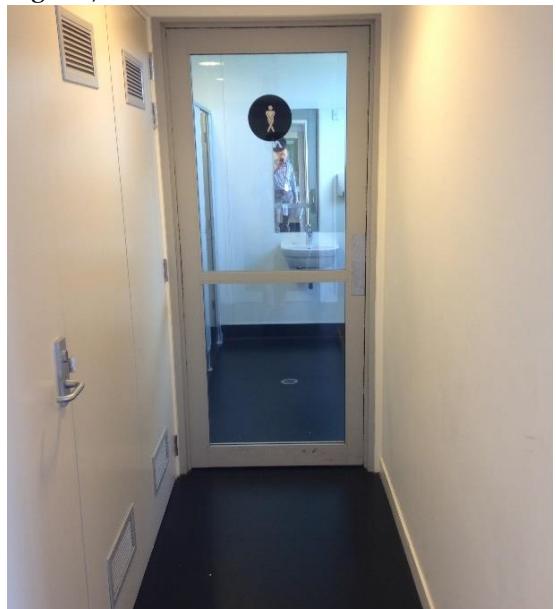
Figure 8

- Staff have reported that the accessible bathroom doors are difficult to manoeuvre through for wheelchair users. For example, in some areas the door handle is located too close to the adjacent (perpendicular) wall to allow easy operation. See Figure 8.

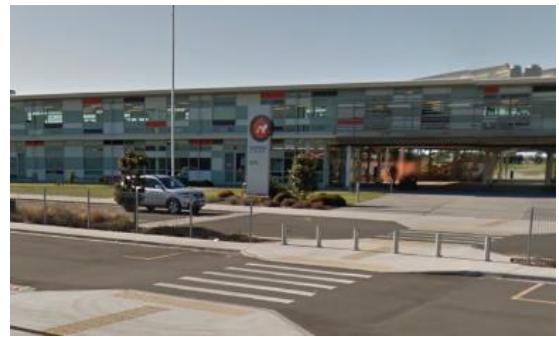
Figure 9

- The perimeter of the site is largely secured with metal pool-type fencing, which is both resilient and effective at securing the school boundary according to staff. Metal pool type fencing also provides a transparent barrier between the main road, the school and the drop-off zone. Bollards are provided at pedestrian crossings. See Figure 9.

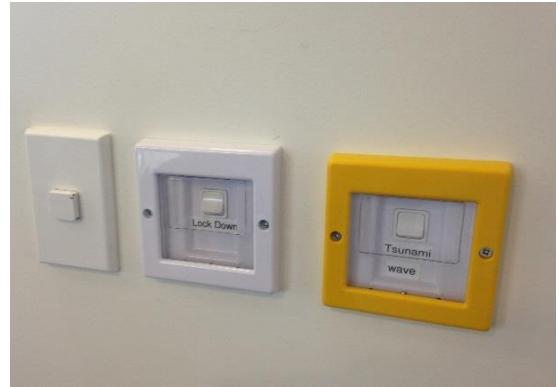
Figure 10

- There are panic buttons, sounder alarms and PA system in place for use in emergency situations such as lockdown or tsunami warning. See Figure 10.
- The exterior car parking and drop off areas are lit via overhead street lighting, which staff report is particularly effective for them during winter when they may be leaving after dark.

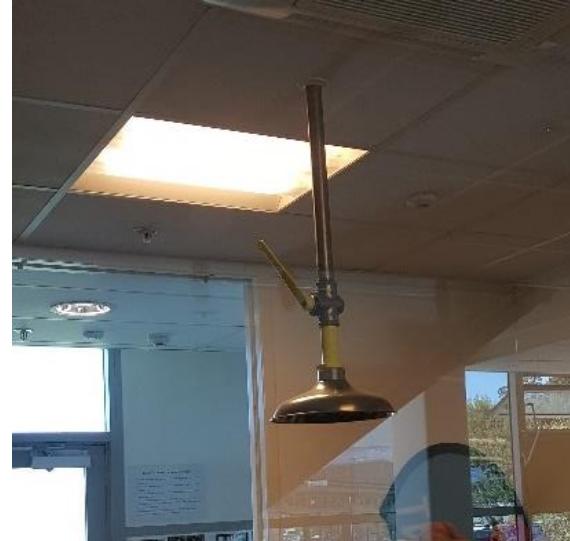
- Eye wash stations and emergency showers are provided in appropriate practical areas, in line with MoE guidelines of the time. Extraction systems have been installed at the source of pollutants (e.g. science areas, near photocopiers/printers). See Figure 11 of an emergency shower.

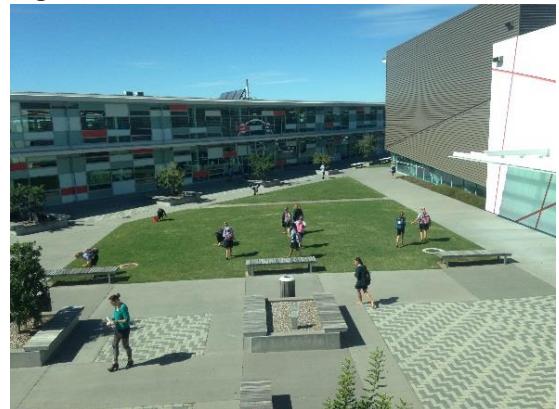
Figure 12

- Each teaching space has oversight to parts of the college grounds. Teachers reported that they appreciate the level of oversight available from the teaching spaces. See Figure 12.

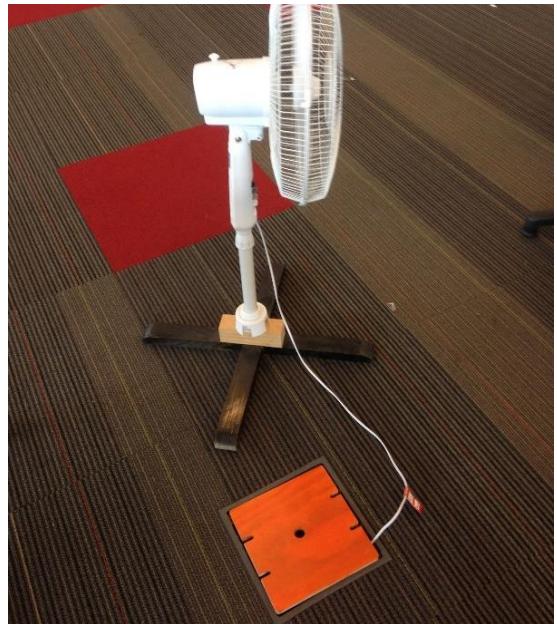
Figure 13

- Free standing, temporary fans have been added to learning spaces to assist with air circulation, as users felt the level of ventilation provided by the passive ventilation was insufficient. The users do not like having these fans as they are noisy and their power cords present a trip hazard. See Figure 13.

- Staff advise that the floor box covers to power points within learn spaces were not robust enough and a number were damaged through general use, presenting trip hazards. The covers to these have been replaced with more robust, plywood covers at the college's expense. See Figure 13.

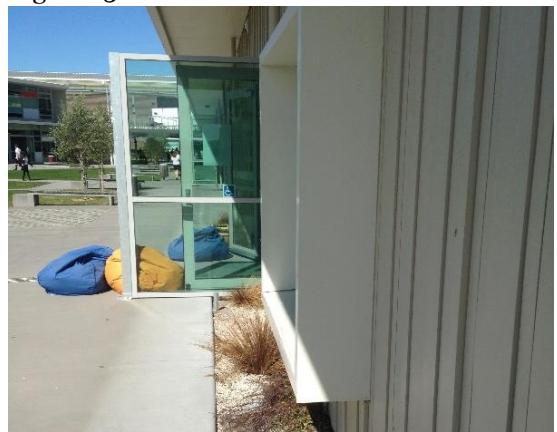
- There were initial concerns around risk of injury to users and potential damage due to the exterior doors opening out onto circulation routes around the building, as well the effect of wind on these doors. To resolve this, external wing walls/screens have been installed at some building entrances post build. See Figure 14 of the external wing wall/screen providing protection to a building entrance.

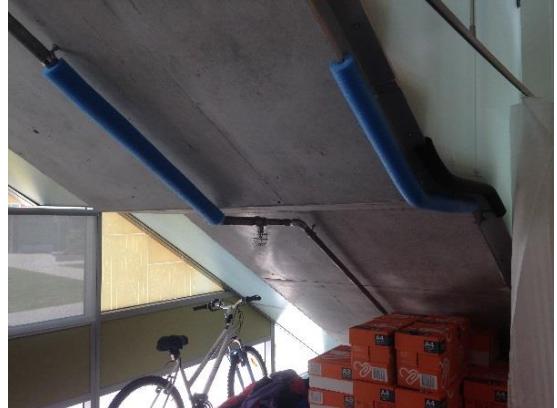
Figure 15

- Some structural elements and building services have been left exposed as a learning resource for students. However, following the build these had to be covered or additional protection installed in some areas to reduce the risk of injury to users - in particular the bracing elements in the gymnasium required covering. See another example of the exposed pipes underneath the stairs in Figure 15.

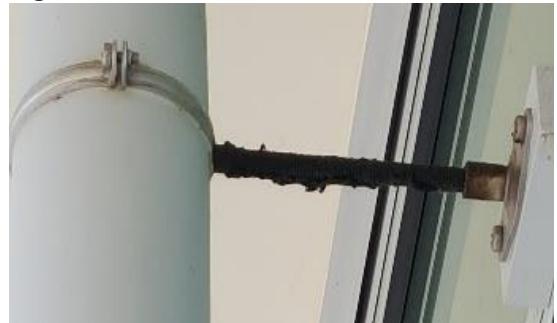
Figure 16

- Corroded pipe supports to the central undercroft area require replacement. The level of corrosion present suggests incorrect specification for the coastal environment. See Figure 16.

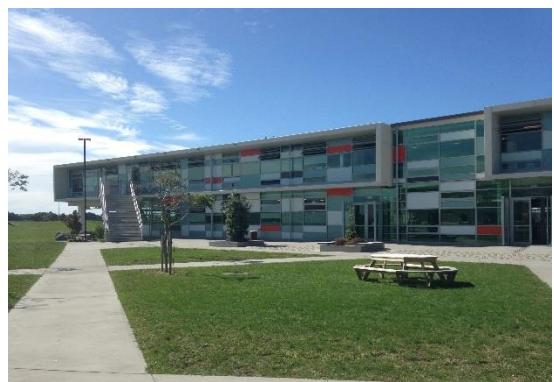
Figure 17

- Fixed outdoor seating is provided within the wind-sheltered grassed/paved areas between buildings. Staff report that the provision of seating to encourage use of external areas. The school has also funded additional relocatable timber tables to enhance the area. See Figure 12 and Figure 17.

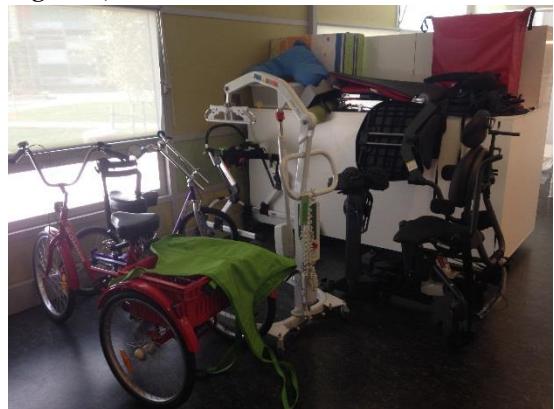
Figure 18

- The high dependency unit (bathroom) has a hoist installed for assisting with students. Wheel chairs and a mobile hoist are provided for the users. See Figure 18.

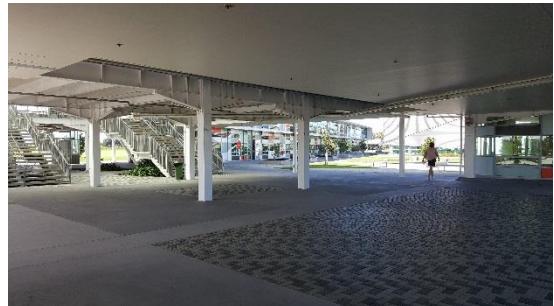
Figure 19

- The large covered area under the walkway provides shelter from the elements and is used by the school as an extension of the teaching spaces. It is also a space for staff and pupils to gather and meet. See Figure 19.

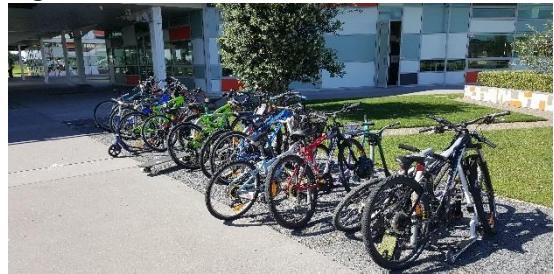
Figure 20

- Uncovered bicycle locking/storage facilities (bike racks) are available on school grounds. According to staff these are well used by the students, and the location of the racks to allow oversight has been appreciated in terms of the additional security this provides. See Figure 20.

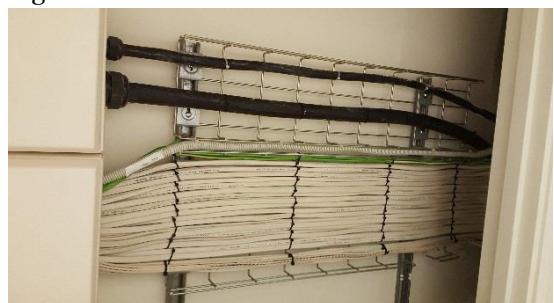
- Switchboards / electrical cables are tidily installed, well labelled and protected within locked enclosures or service cupboards. See Figure 21 of a wall-mounted racking system within a cupboard to contain the cables.
- Wi-Fi networking is installed throughout the school and students are able to connect to the network with their own devices, which staff appreciate as this offers easy access to resources. Multimedia facilities for video/audio are provided in the library and IT suites. Mobile Computers on Wheels (COW) units are used for laptop charging, and have met the needs of the users well. See Figure 22

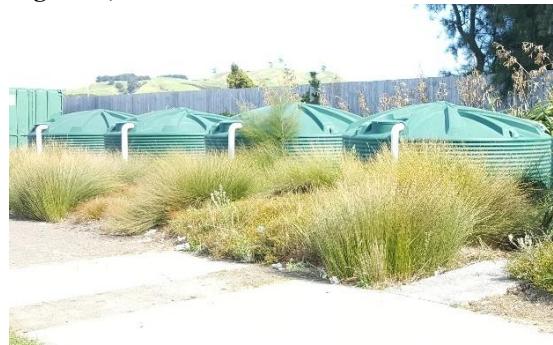
- The buildings employ rainwater harvesting from the roofs, with the water used for grey water uses such as toilets. There are five 5000 gallon water storage tanks on site. See Figure 28 of the storage tanks.

- Users appreciated the aesthetic appeal and practicality of the landscaping around the school grounds. To the south the landscaping visually obscures the rainwater storage tanks – see

Figure 28. To the north the landscaping and plantings provide some relief from wind to the area between arms of the buildings.
