Report on Structural Testing of a Standard Classroom Block in Christchurch in December 2013

'Dominion' Block, Hammersley Park School, Shirley, Christchurch

February 2014

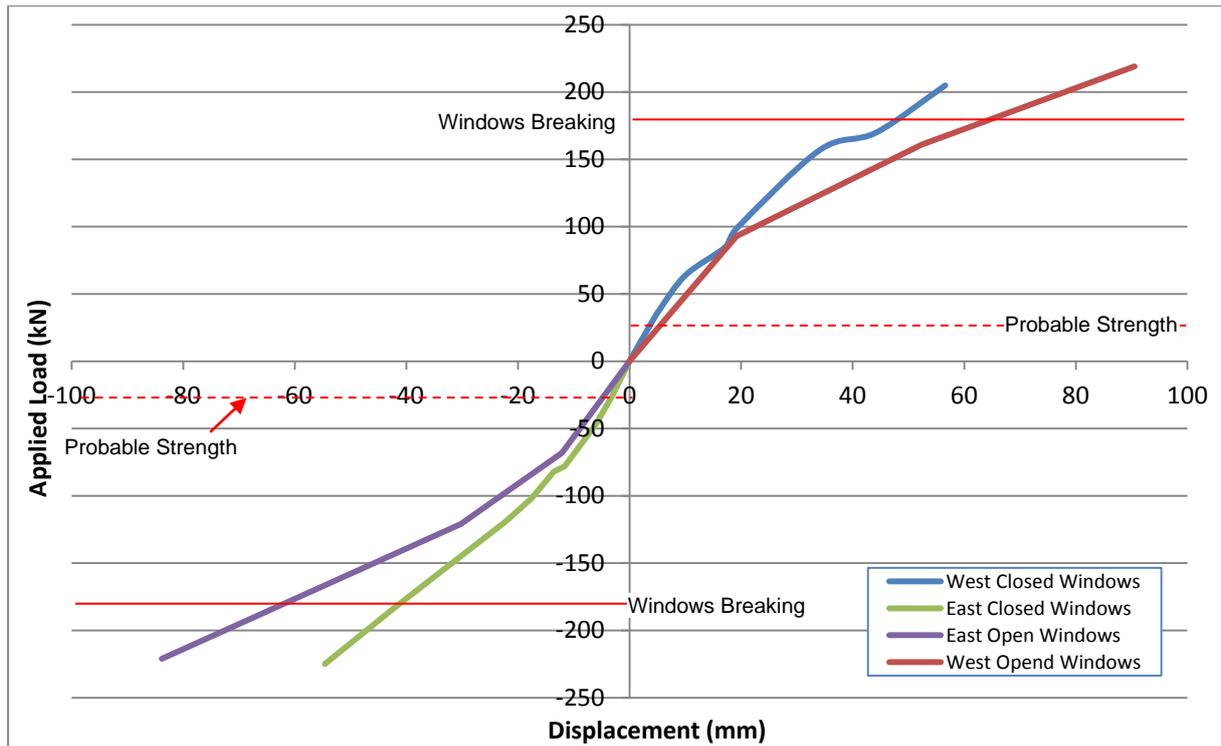
Figure 1: Longitudinal Test – Load vs. Displacement Plot

For the longitudinal test, the first glazing crack occurred in the front façade at loading to 180kN. Rear high-level windows started to shatter at loads of 200kN. The building withstood a maximum loading of 262kN before a local failure occurred at the points of load application. At this maximum load level there was no sign of imminent collapse.

In Table 3, the *actual strength achieved* is shown as 200kN, reflecting the point at which a life safety condition was reached by the failure of the high level windows. It is important to note that this level of strength achieved does not represent structural failure, a condition that was not actually reached in the longitudinal test. This form of glazing vulnerability could be readily remediated by the application of a safety film.

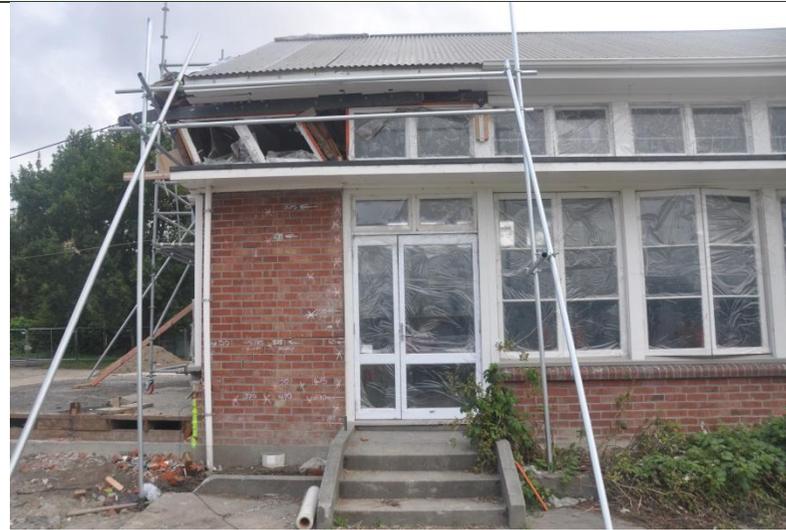
Figure 2.6: Local failure at the connection point at end of longitudinal test

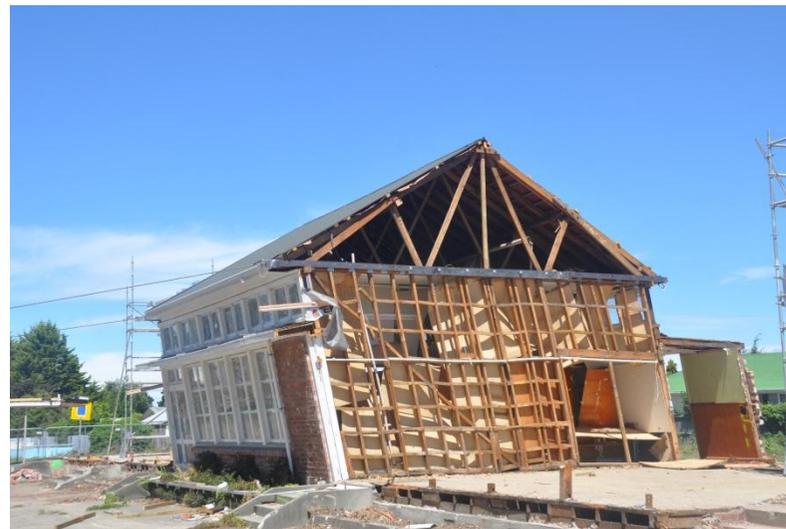
Figure 2.8: Transverse test showing high levels of drift

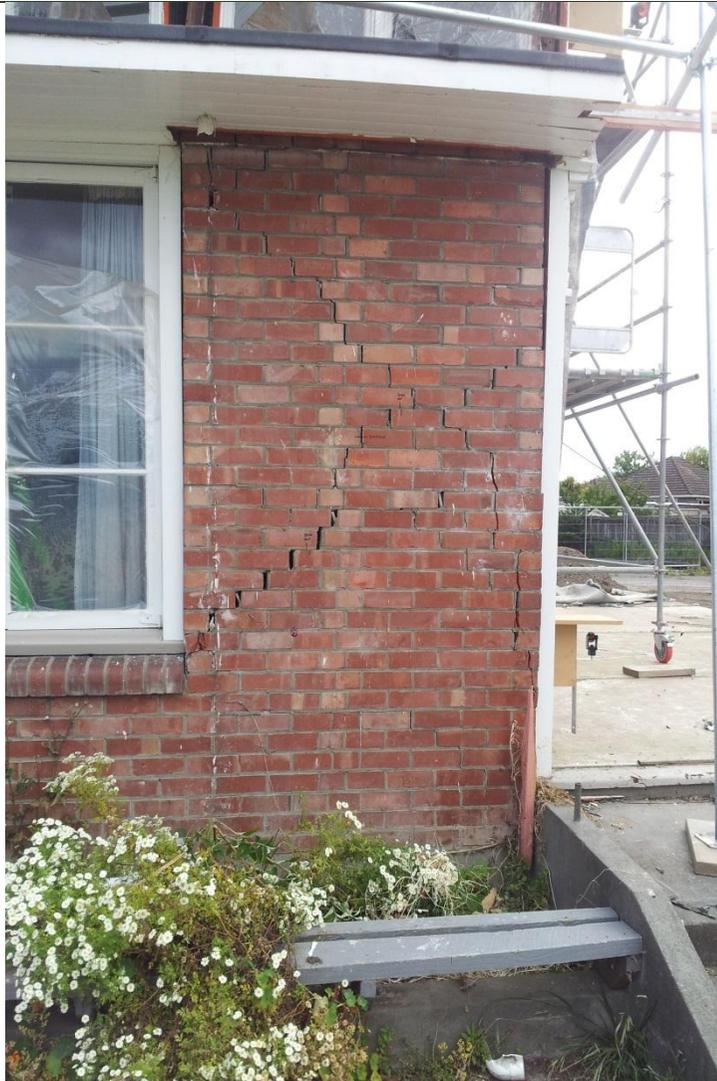
Figure 2.9: Cracking of veneer attached to the braced timber wall frame (longitudinal test)

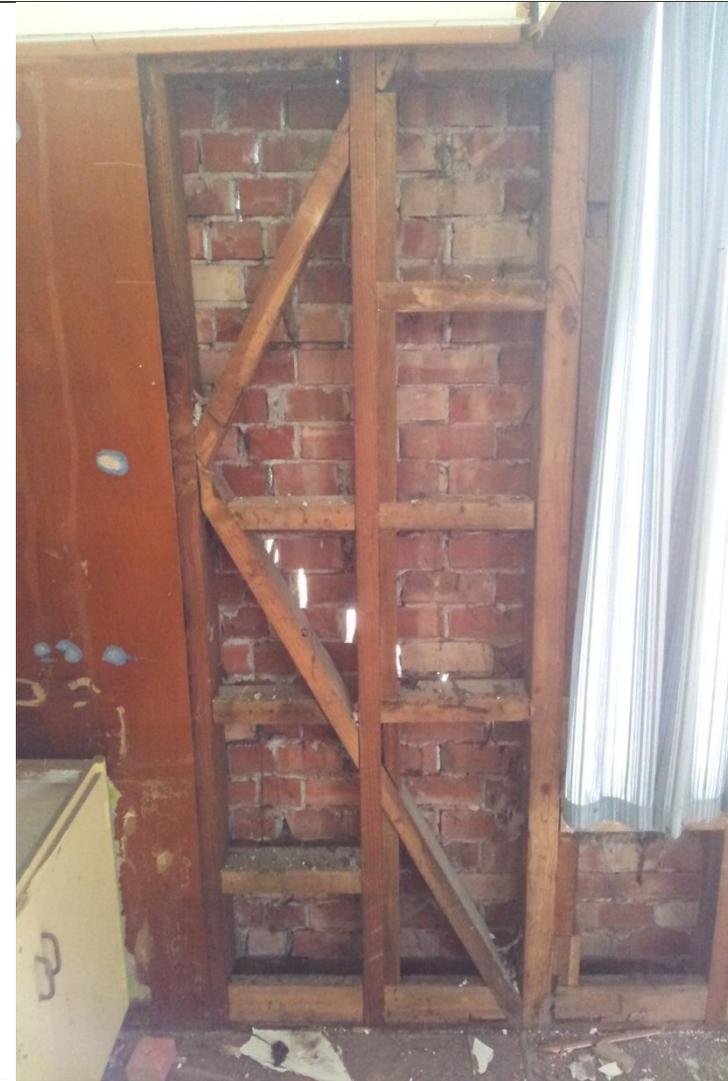
Figure 2.10: Wall bracing in panels on the north wall (longitudinal test)

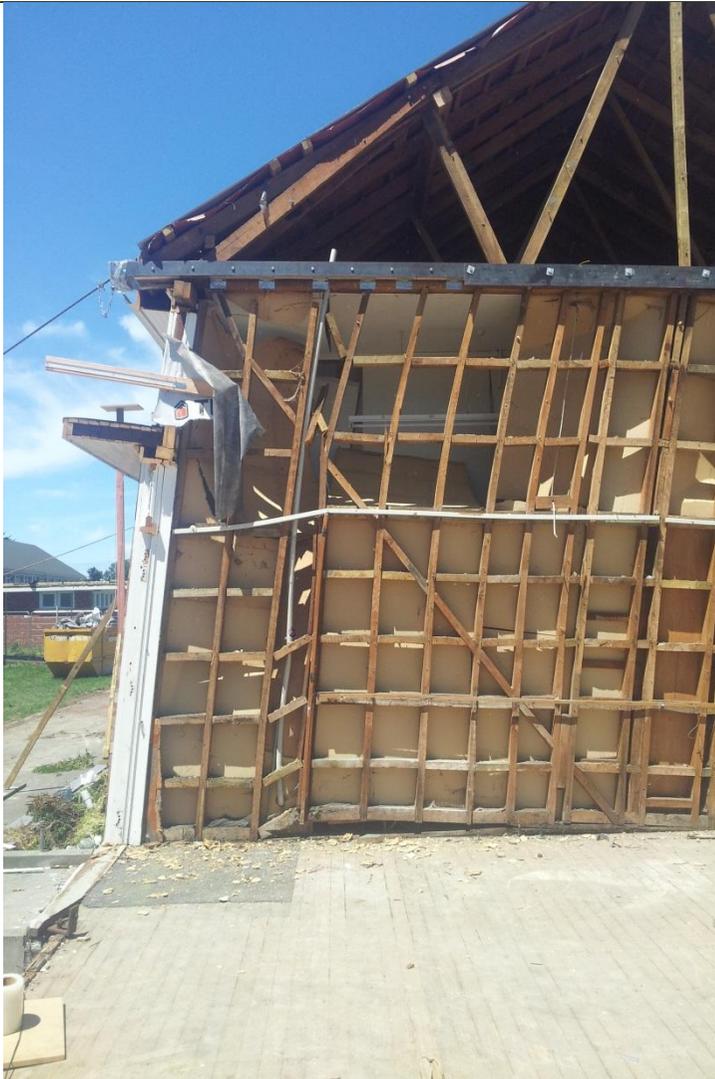
- Plumbing work that had been carried out in the classrooms in the past had removed the continuity of the angle braces in one of the walls (as shown in Figure 2.10, Appendix 1). Alterations of this type have a detrimental effect on a buildings capacity, are difficult to identify without removing wall linings, and are likely to be fairly common in school buildings.
- This test showed that the classroom also exceeded its calculated probable capacity in this direction.
- The calculated transverse strength of the block is 51kN, which is approximately 130% NBS. Information from the test suggests that the actual transverse strength is likely to be significantly in excess of 100% New Building Standard.
- The single classroom was tested to destruction. Drifts well in excess of 5.6% (200mm) were achieved with the building still able to support itself under gravity loads (see Figure 2.11).

Figure 2.11: Western transverse wall showing failure of cross bracing member (previous plumbing work interrupted the continuity of the angle bracing)

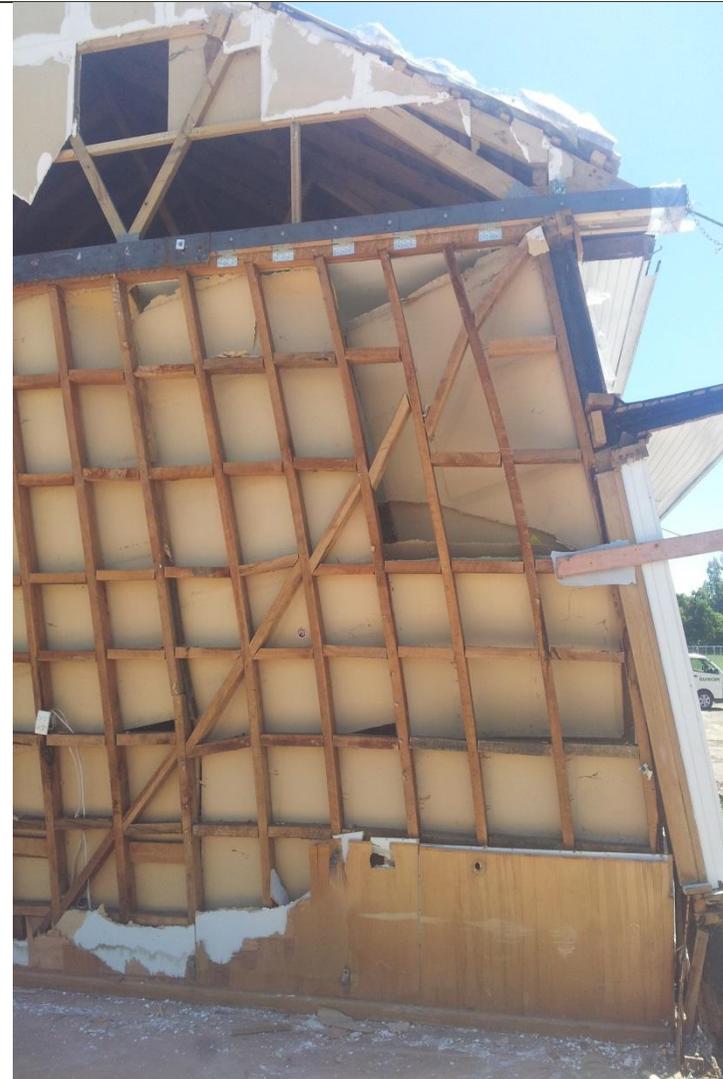
Figure 2.12: Eastern transverse wall showing failure of cross bracing member
