Two-Storey Nelson Blocks – Physical
Inspections of Existing Buildings and
Effects on Previous Seismic
Assessments

Reference: 233016
Prepared for: MOE
Revision: 4
21 January 2015

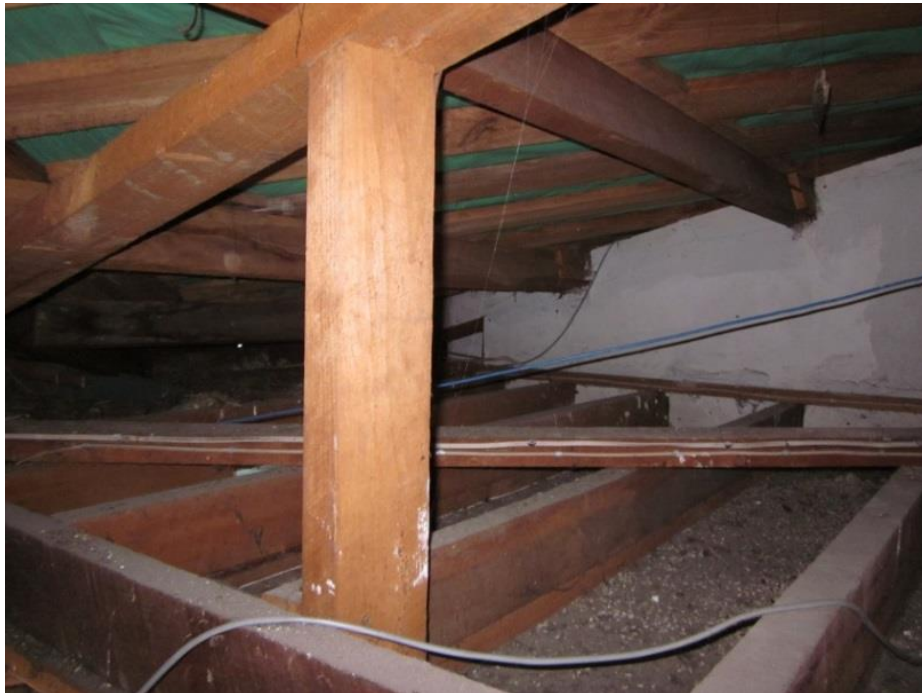
Figure 3: Inspected Roof Framing in End Portion of the 'H' Section

The key variations that have an effect on the potential seismic performance determined from the previous seismic assessment were found in the roof space. At the ceiling level in the end portion of the 'H' section, it was found that all truss bays contained diagonal timber cross bracing (one set of cross braces per bay). This is more cross bracing than was specified in the original drawings. Since the original design assumptions already arrived at a capacity of above 100%NBS for this element, this variation has no effect on the results from the previous assessment. The roof framing in the end portion is shown in Figure 3 below:

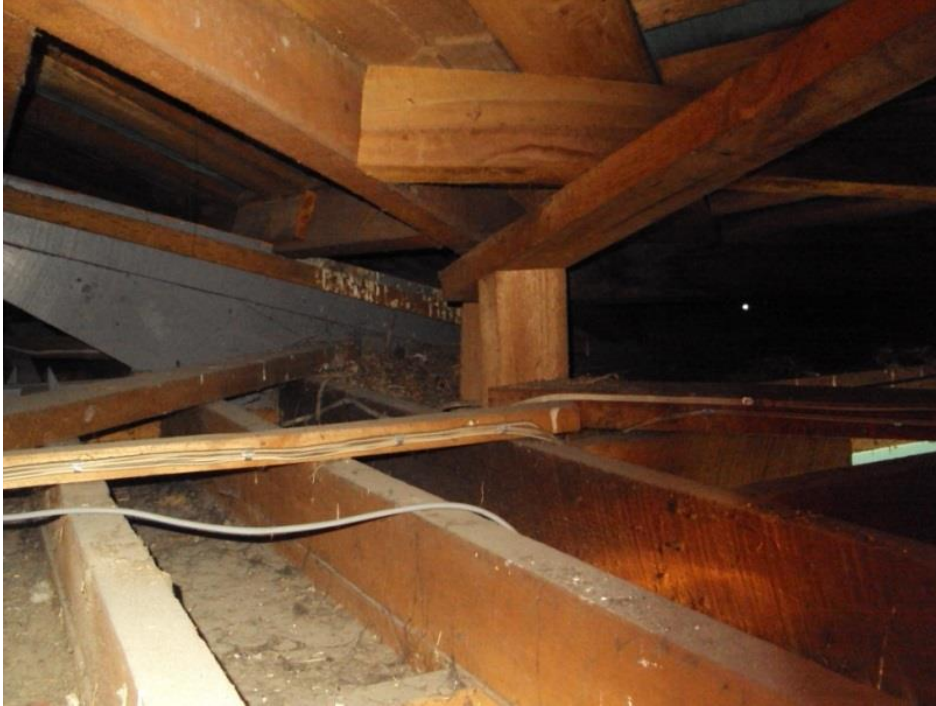
Figure 4: Roof Connection Transition between End Portion and Central Portion

Another key variation was at the roof connection at transition between the end and central portions of the 'H' block. Timber cross bracing in the ceiling space in the end portion was found to connect to the timber trusses. Ceiling bracing in the central portion terminates in the corners of this segment directly adjacent to the end portion. This detail is shown in Figure 4 below:

This bracing is not shown in the original drawings and allows for a load transfer between the end portion and central portion to occur, which was not assumed in the original calculations. On the first floor, the timber framed walls in the end portion can provide additional capacity to resist some of the seismic loads from the central portion. This increases the longitudinal capacity of the central portion. On the ground floor, the concrete walls in the end portion are able to provide additional capacity to the seismic loads generated by the central portion. This finding effectively allows the building to be considered as a 'single' building effectively tied at the junction between the notional 'end' and 'central' blocks.

The key variations found in the Nelson Block at Mairehau High School were in the roof space. It was found that the roof bracing connection between the end and central portions of the structure was greater than previously assumed, based on what was shown on the original drawings. This will allow some transfer of seismic load between these two segments, increasing the overall seismic bracing capacity of the building.

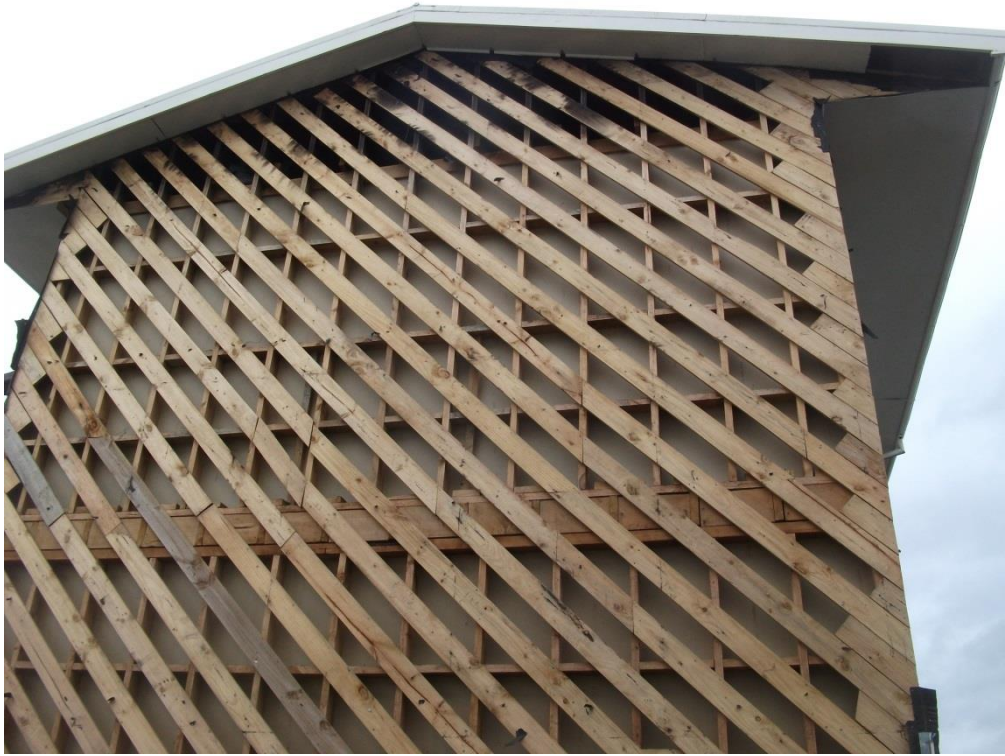
Figure 5 – End Block Elevation Showing Hit and Miss Sarking

In one of the end portions of the 'H' section, the exterior longitudinal walls contained 'hit and miss' diagonal sarking on both levels as opposed to the full diagonal sarking that is shown in the original drawings. This reduced the assumed bracing capacities of these wall elements. The likely bracing capacity of 'hit and miss' sarking is considered to be 50BU/m, which is the recommended bracing capacity for a standard timber bracing wall as recommended by MOE guidelines. This effectively reduced the overall %NBS seismic capacity in the longitudinal direction from what was determined in the Aurecon seismic assessment. This detail is shown in Figure 5 below:

In the Nelson Block at Upper Hutt College, the exterior walls in the end portions of the structure were found to contain 'hit and miss' sarking as opposed to full diagonal sarking. This will reduce the longitudinal bracing capacity of the structure from what was calculated in the seismic assessment.

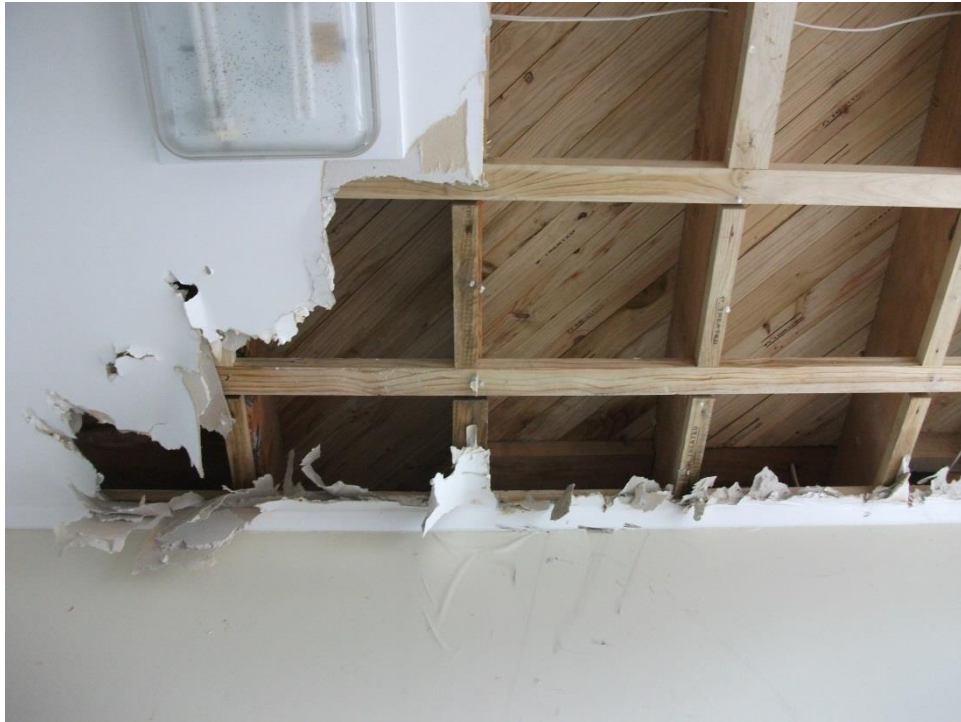
Figure 6 - First Floor Diaphragm at the Interface between the End and Central Portions

A physical inspection of the roof and floor diaphragms found the end and central portions of the 'H' section were effectively connected. In the roof space, the ceiling cross bracing in the end portions were connected on the same wall line as the adjacent ceiling cross bracing in the central portion. At the first floor level, the diagonal timber tongue and groove boards in the central portion were found to be well connected into the end portions. This finding effectively allows the building to be considered as a 'single' building effectively tied at the junction between the notional 'end' and 'central' blocks, which was not assumed in the original assessment calculations in the transverse direction. The transverse timber framed walls in the central portion can therefore provide additional capacity to resist seismic loads generated by the end portions, providing an increase in the %NBS seismic bracing capacity in the transverse direction.

It was also found that the end and central portions of the structure were effectively connected at the roof and first floor level. This will increase the %NBS seismic capacity from that calculated in the original assessments.
