POST OCCUPANCY EVALUATION

AMESBURY SCHOOL CHURTON PARK, WELLINGTON

May 2015

Date: April 2015
Reference: 1-46083.00
Status: Final v15

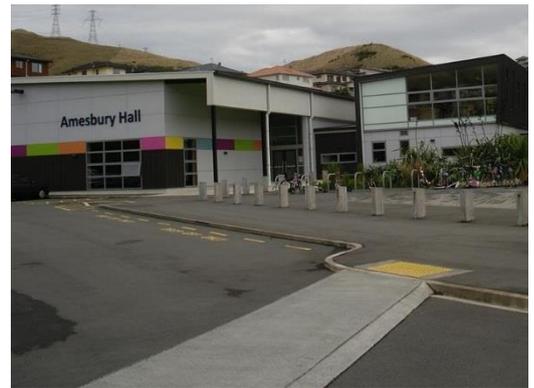
Figure 3

- High dependency space at the southwest corner of Block A is used as a store room and thus redundant - unable to access the facility.
- The High Dependency Space had no visible emergency call button.
- The High Dependency Space had no visible emergency general power outlet for connecting to a hoist.
- No clearly defined main reception entrance or exterior signage.

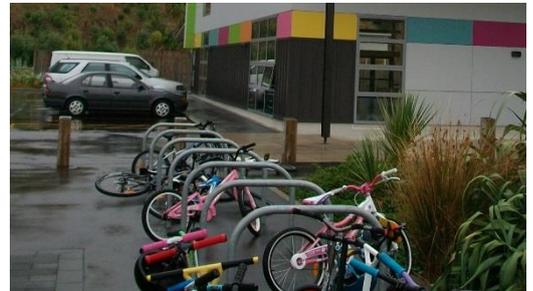
Figure 7

- Scooter park is insufficient for number of students who use it.
- Bicycle storage is at front of property and in view of and accessible from the main road. Large metal hoops are not ideal and due to this many bicycles were lying on the ground. See Figure 7. The bicycle park to the west of Block A (adjacent maintenance shed) is unused, and not visible from school entrance - no signage.

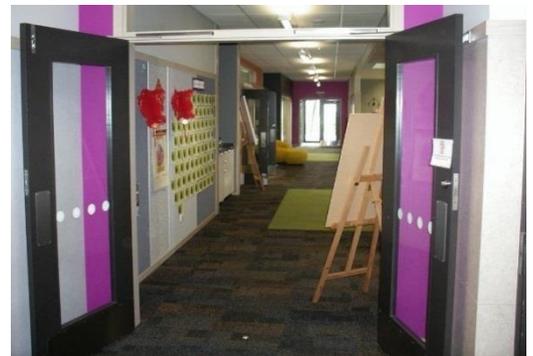
Figure 8

- The school reported general satisfaction with health & safety aspects of the design.
- Building services have been installed in accordance with standard practice without undue protrusion into hallways or escape routes. See Figure 8.
- RCD protection has been installed on power circuits accessible for use by students.
- PA system is installed which is used for emergency only.
- Underfloor heating is effective for thermal comfort.
- Mechanical ventilation is installed within toilets.
- Extract ventilation is provided within the dedicated printer bay.
- The school is surrounded by hills with residential properties overlooking the grounds. Neighbours have been vigilant with strangers entering school, and have advised staff at the time this occurs.

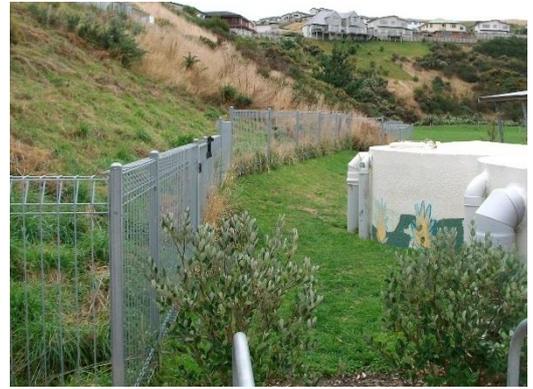
- No active security system in use at the school, night lighting is permanently on around the exterior of the building. Only minor vandalism has occurred since the school has been operational.
- Fencing provides separation from a waterway to the north of the site. See Figure 10 of west boundary.
- Staff report entrances are generally secure - minimal problems with this aspect. External after hours lighting has made visibility to school entrances very good after hours.
- Staff Space overlooks the central courtyard and front car park.

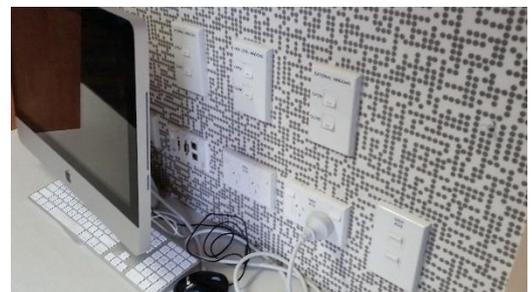
- General power outlets have been installed as required for teaching spaces and administration areas. Power outlets have also been installed above bench levels where necessary to facilitate access and use. See Figure 17

- Generally sufficient numbers of general power outlets are provided within the teaching spaces, admin and circulation areas. It was observed that laptops and tablets are being charged using one or two power points connected to splitter boxes. See Figure 17 and Figure 18. Up to 10 laptops are charged in this way. This was discussed and it would seem to

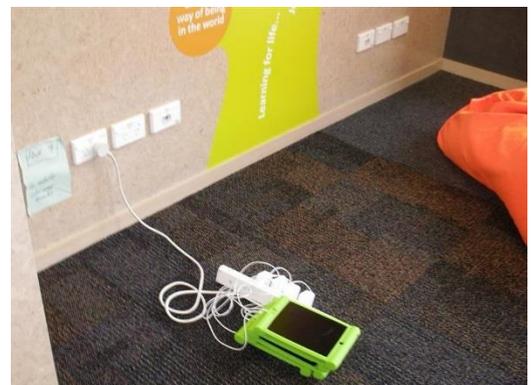
Figure 18

be a school preference. The school did have a “computers on wheels” unit (COW) for charging of laptops.

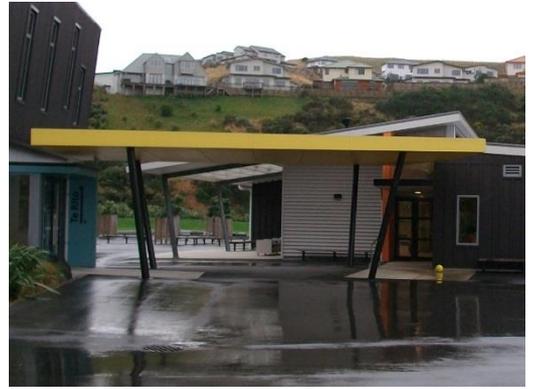
Figure 19

- Benches and water outlets well provided for within designed wet areas. These appear to be used to full capacity in senior space.
- Covered walkway is provided between buildings. See Figure 19.

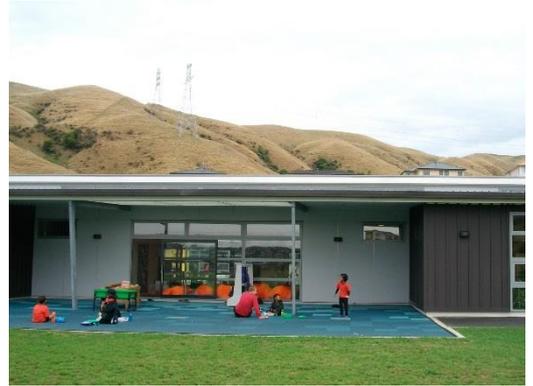
- Covered outdoor learning spaces are easily accessible and are generally located directly outside teaching spaces. See Figure 20.
- One drinking fountain per two classrooms provided. Made from stainless steel.

- No space provided for laptop/tablet storage and charging in design. Power outlets for device charging reportedly generally satisfactory in number, but placement not ideal. See Figure 20

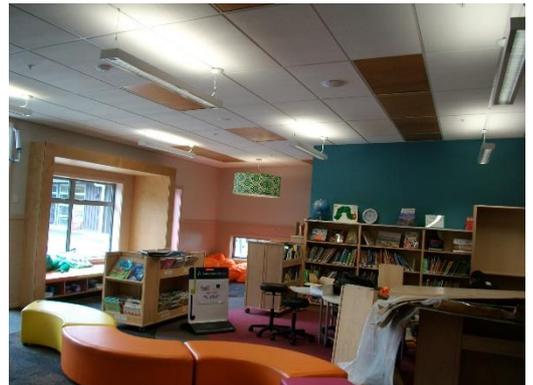
- Library well used by students. Accessed from reception makes the library a focal point. Library is multipurpose. Students are able to check out books themselves unsupervised. Big sets of library books are stored elsewhere (in the Koru Hub). Mobile book shelves can go to hubs. Students have been using library as "local library" after school as they can use and check out themselves. See Figure 21 for a view of the library.

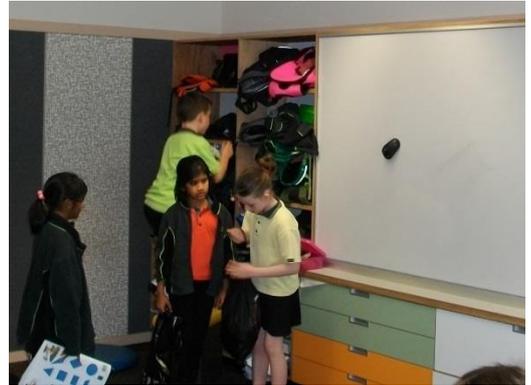
Figure 28

- Storage behind movable whiteboards adjacent to student storage space within the teaching spaces was generally unused.
- Student storage space located within teaching space for 25 students has 12 bag specific shelves provided. Some too high for students to access – requiring stools. See Figure 28.

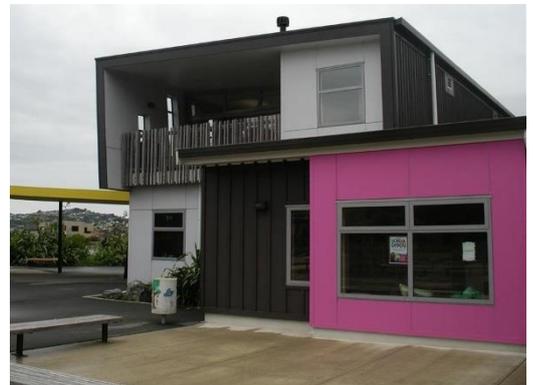
Figure 32

- Insufficient overhangs to control glare from sunlight. Lack of soffit overhangs at eaves exposing cladding. See example of minimal overhangs in Figure 32.

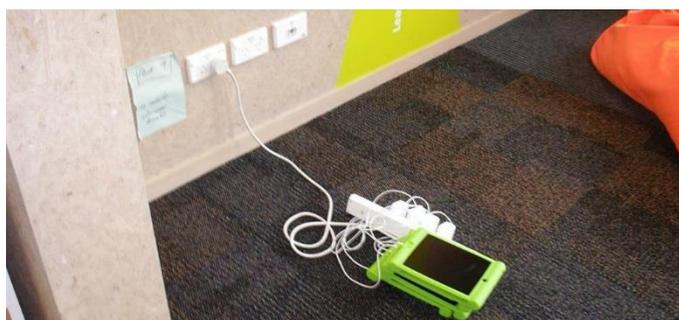
Figure 40 – Tablets charging in learning areas.

Generally sufficient numbers of power points are provided within the teaching spaces, admin and circulation areas. It was observed that laptops and tablets are being charged using one or two power points connected to splitter boxes. Up to 10 laptops are charged in this way. This was discussed and it would seem to be a school preference. The school did have a computers on wheels unit "COW" for charging of laptops.
