# POST OCCUPANCY EVALUATION

## HOBSONVILLE POINT SECONDARY SCHOOL HOBSONVILLE POINT, AUCKLAND

**June 2015**

Date: June 2015  
Reference: 1-46083.00  
Status: Ver 7

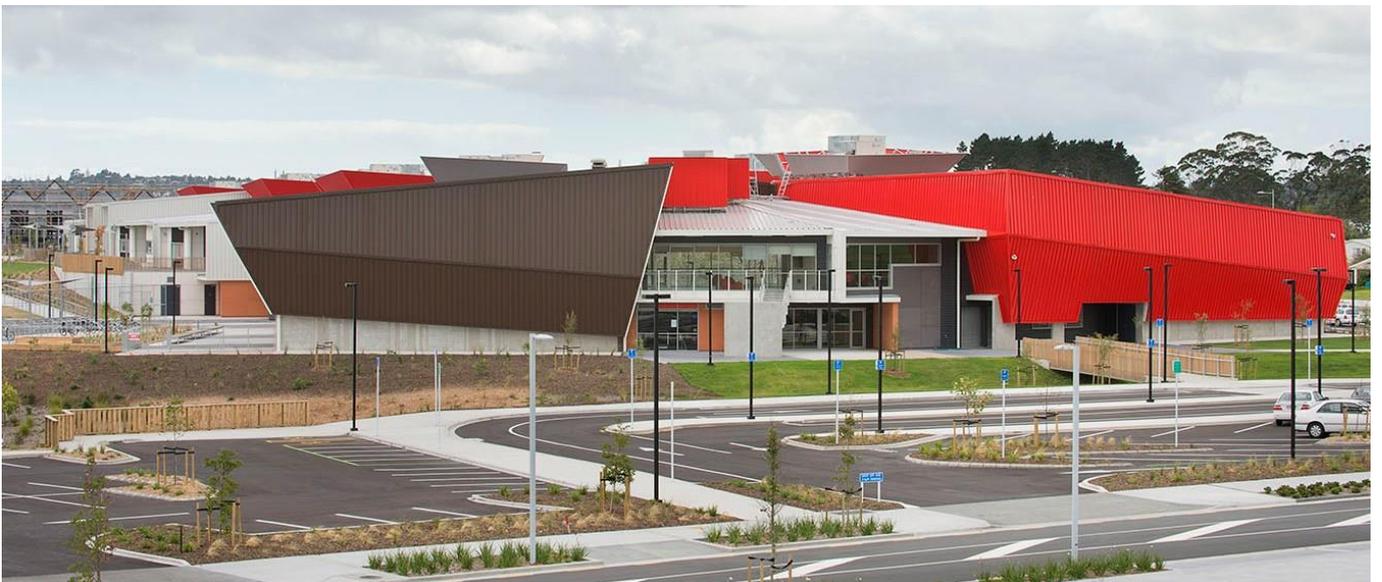
Figure 1

- The site has level and ramped access to the entry, the perimeter of the school and the rear northern playing fields. See figure 1.
- Scooter racks are located at the front of the school for staff and at the rear northern courtyard for students. See Figure 3.

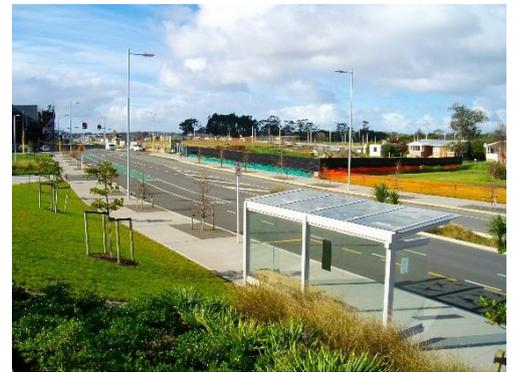
Figure 4

- A covered drop off zone is provided to a secondary entrance and a bus stop is located on the road frontage below. See Figure 4.
- The covered main entrance is lobby protected with automatic opening doors and is easily accessible from adjacent level access car parking. See Figure 5.

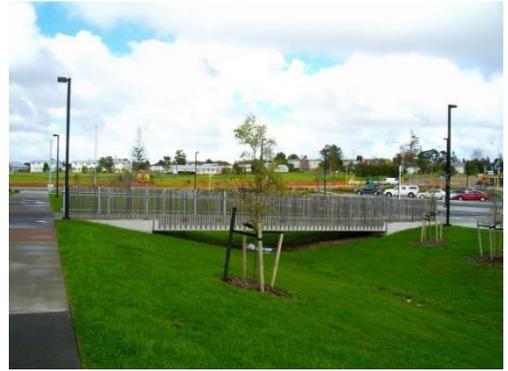
- The facilities management by external providers has transferred the responsibility for property management away from the Principal.
- The main entrance doors are fully automatic and open into a lobby which is effective in reducing draughts and heat loss
- Lighting has "on", "off" and "automatic" settings with light and motion sensor automatic control supplementing the use of natural light.
- Water supply has isolating valves, back flow prevention and adequate pressure.
- Distribution board has a maximum demand meter.
- Landscaping provides water run off attenuation. See Figure 34
- Designed to achieve a 5 star rated Green Star building.
