# POST OCCUPANCY EVALUATION

## PAPAMOA COLLEGE PAPAMOA, TAURANGA

Date: June 2016  
Reference: 1-46083.00  
Status: FINAL

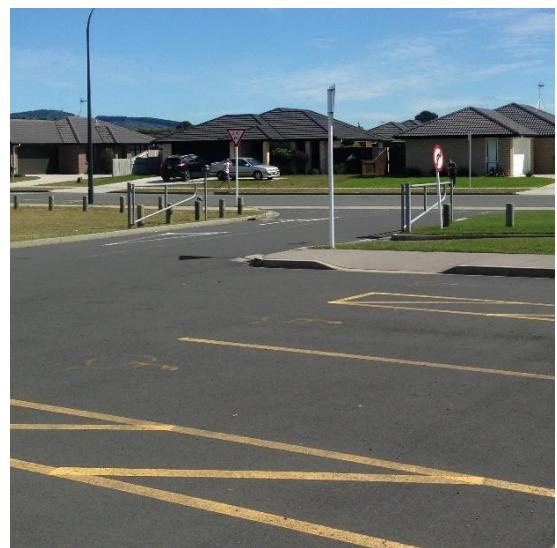
- The majority of the staff and visitor car parking is located off street to the south of the College buildings. The entry to the car park is clearly identified from the road and a barrier secures the car park out of hours. There are further car parking spaces and accessible parking bays located close to the entrance of the car park, which the staff report are well placed and easily accessible. The provision for car parking meets the requirements of the territorial authority. See Figure 4 of the accessible parks adjacent the road entrance and pedestrian path to the main entrance.

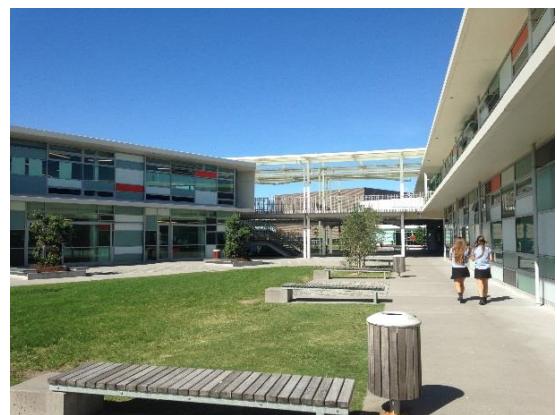
- Building entrances have level thresholds throughout the school, and users reported that the buildings and grounds are highly accessible with wide entrances, pathways and circulation routes. See Figure 5 of the exterior circulation route between school buildings.

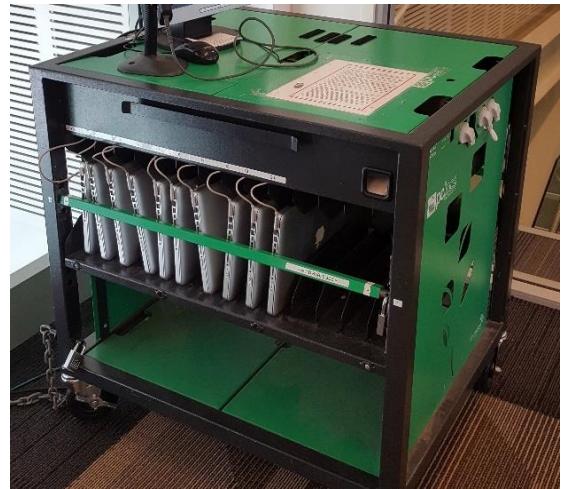
- Switchboards / electrical cables are tidily installed, well labelled and protected within locked enclosures or service cupboards. See Figure 21 of a wall-mounted racking system within a cupboard to contain the cables.
- Wi-Fi networking is installed throughout the school and students are able to connect to the network with their own devices, which staff appreciate as this offers easy access to resources. Multimedia facilities for video/audio are provided in the library and IT suites. Mobile Computers on Wheels (COW) units are used for laptop charging, and have met the needs of the users well. See Figure 22

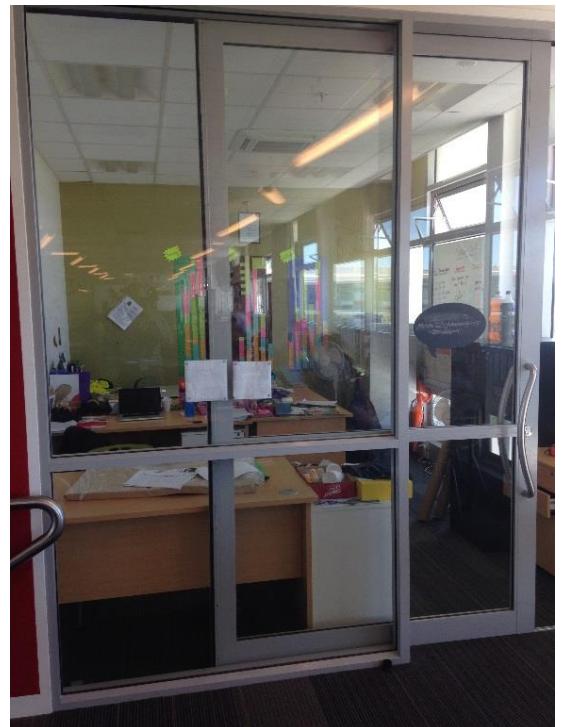
- Staff use the designated break out spaces within the learning areas as teacher work spaces. The Principal reported that that it was originally intended that teachers should be based and work in the main teaching spaces at all times, but this did not work for staff. As a result of the alternative use of the breakout rooms, there are no quiet areas (breakout spaces) available in the teaching spaces for individual or small student group lessons, confidential talks or counselling sessions. See Figure 23 of one of the breakout spaces adapted as teacher work space.

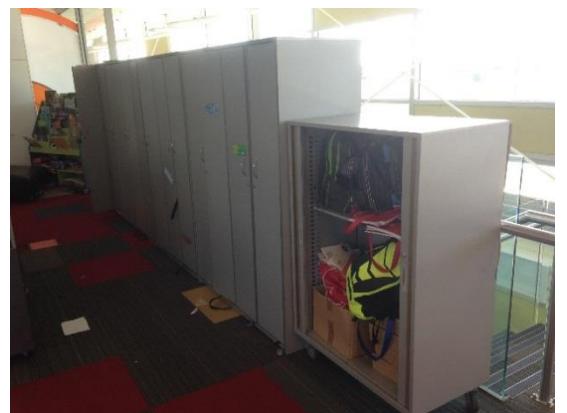
- Staff believe that the space allocated in the design for student storage within the main learning areas was insufficient and not located well. The school has installed lockers at the perimeter of the learning spaces as intended, but these restrict the available daylighting and impede natural ventilation in several locations. See Figure 24 of some lockers within the general learning area.

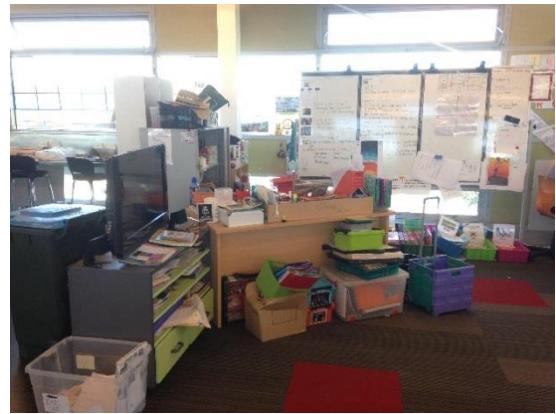
Figure 25

- Due to a lack of alternative equipment and resource storage space (according to staff), boxes and equipment are stored at the perimeter of the learning spaces in front of windows. This reportedly decreases the performance of the natural ventilation system, which staff have now supplemented with free standing and wall-mounted fans. See Figure 25.

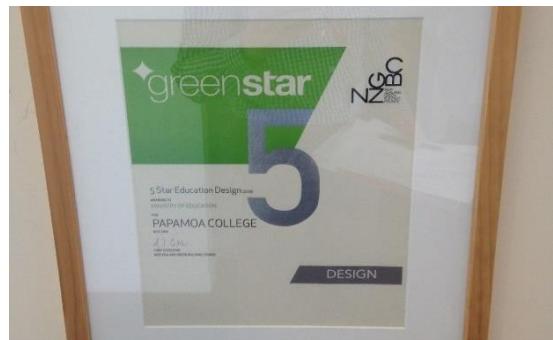
- The College received a 5 star Green Rating Education Built rating in 2015, signifying "New Zealand Excellence" in the sustainable aspects of the school as constructed. Figure 26 shows the certificate on display at the school (the 5 star design rating only was on display).

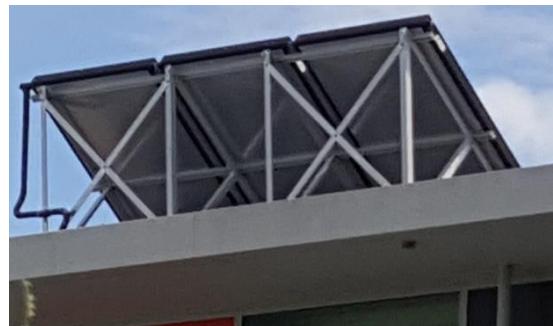
- Hot water generation is by way of solar assisted electric cylinders, which reduces energy use in water heating. Hot water is temperature monitored and pipes where inspected were insulated to minimise heat loss in transfer around the school. See Figure 27 of the roof mounted solar panels.

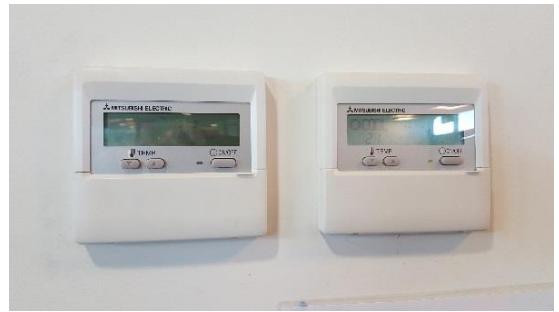
Figure 29

- Heat pumps are installed in selected areas within the administration block, and are easily controlled by users via wall panels with automatic settings – see Figure 29. A decentralised gas system is used for the majority of the school. The gas supply consumption is monitored through the BMS.
