# Establishing the resilience of timber framed school buildings in New Zealand

2014 NZSEE  
Conference

**ABSTRACT:** Following the Canterbury earthquakes, the Ministry of Education has applied significant effort and resources to better understand the seismic performance of its existing buildings. Approximately 90% of its building stock is timber framed low-rise construction, with the majority of these being constructed prior to modern structural design codes. Many of these buildings feature elements such as fully glazed facades that have little quantifiable strength, often leading to low assessment ratings. However from a structural perspective, it has been a common view amongst engineers that these buildings pose little life safety concern.

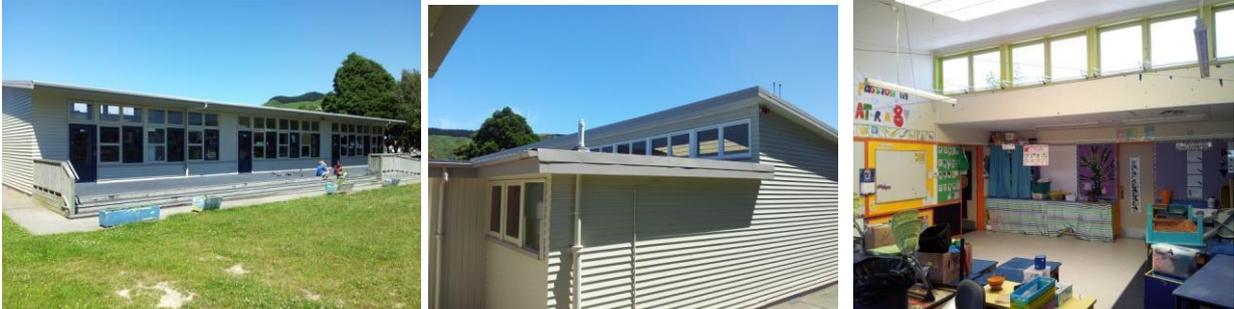
Front (fully glazed)

Back: High-level glazed (or “clerestory”) section

**Figure 1. Avalon block (examples)**

The test involved two classrooms that formed part of a four-classroom “Avalon” block at South End School, Carterton, Wairarapa. Commonly constructed in the late 1950s and early 1960s, this timber framed classroom block features a front wall that is essentially fully glazed, with no recognisable structural bracing panels. The classroom ceiling features a high-level vertical glazed (or ‘clerestory’) section, again with no identifiable form of bracing to connect the diagonally braced higher section to the tongue and grooved braced lower section of ceiling over a section of each classroom and the cloakroom area. Extensively glazed facades and clerestory windows are also present in a number of other standard classroom designs.

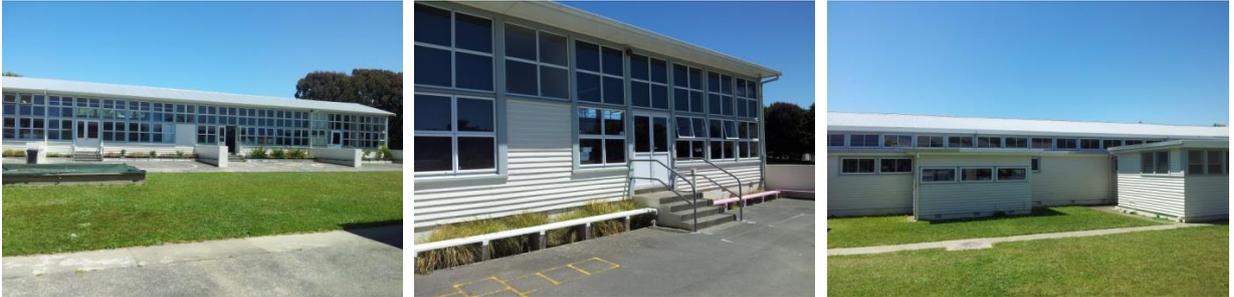
Front (fully glazed)

Front

Back

**Figure 2. Dominion block (examples)**

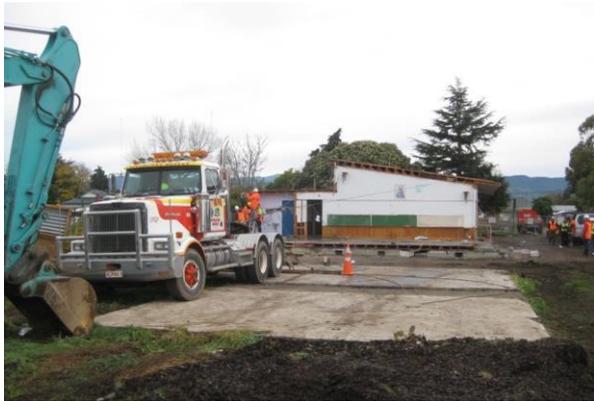
Figure 3. View of the Avalon block during testing

Two classrooms were tested from the block of four to ensure that the strength of the building could be reached with the available test equipment. Lateral loads were applied cyclically to both ends of the two classrooms at roof level (Figure 33) and also an isolated transverse wall using hydraulic actuators integral to house moving trucks connected to the 5<sup>th</sup> wheel of each truck. The loads were distributed to three attachment points on each end of the building using steel pre-stressing tendons. The 5<sup>th</sup> wheel attachments were connected directly to hydraulic actuators having 30 tonnes of pulling capacity and a stroke length of approximately 1.4 m. They could also be held at displacements corresponding to target load increments to allow for displacement recording using surveying station equipment.

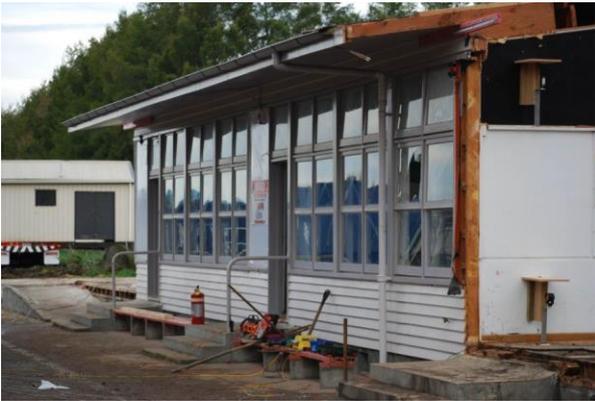
Figure 4. Building at end of longitudinal test

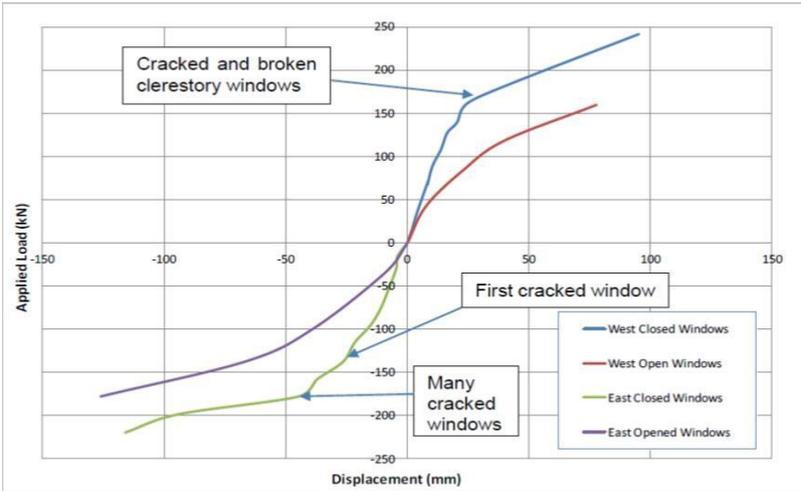
Figure 5. Load-displacement backbone plots for windows closed and windows open

Throughout the testing of the classrooms, loads were recorded using load cells on each of the steel tendons and the displacement was recorded near the roof apex using a rotary potentiometer. In addition, displacements of selected locations on the end walls were recorded at peak loads and zero loads using surveying station equipment. Load levels were increased in approximately 20 kN increments at each end of the building and held at each increment so that displacement measurements could be obtained. The majority of testing was undertaken with the windows closed but at different

times during testing load was applied with all of the windows open for comparisons of stiffness. Figure 5 shows the two load-displacement backbone plots for pulls to the east and the west with windows opened and closed. Loads were increased up to the point of significant building damage, but at no time was there imminent collapse of the building.

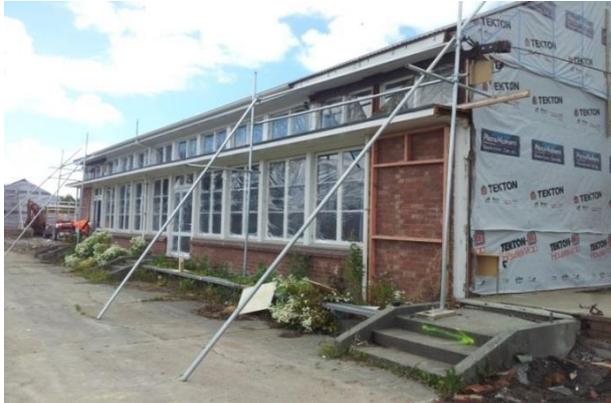
**Figure 6. The Dominion block in early stages of the longitudinal test**

A similar process was employed by BRANZ to test two classrooms of a Dominion block at Hammersley Park school in Christchurch in the longitudinal direction and a single classroom in the transverse direction in December 2013 (Figures 6 and 7). For these test buildings, the load was applied at the wall top plate level on both sides of the building because the roof was well braced in the ceiling plane and not expected to have any greater weaknesses than the side walls.

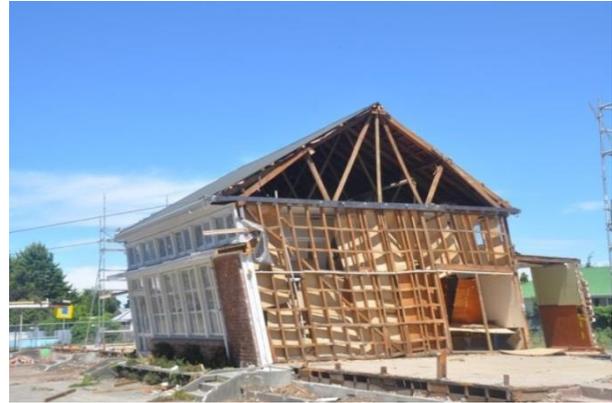
**Figure 7. Building showing high levels of drift during the transverse test**

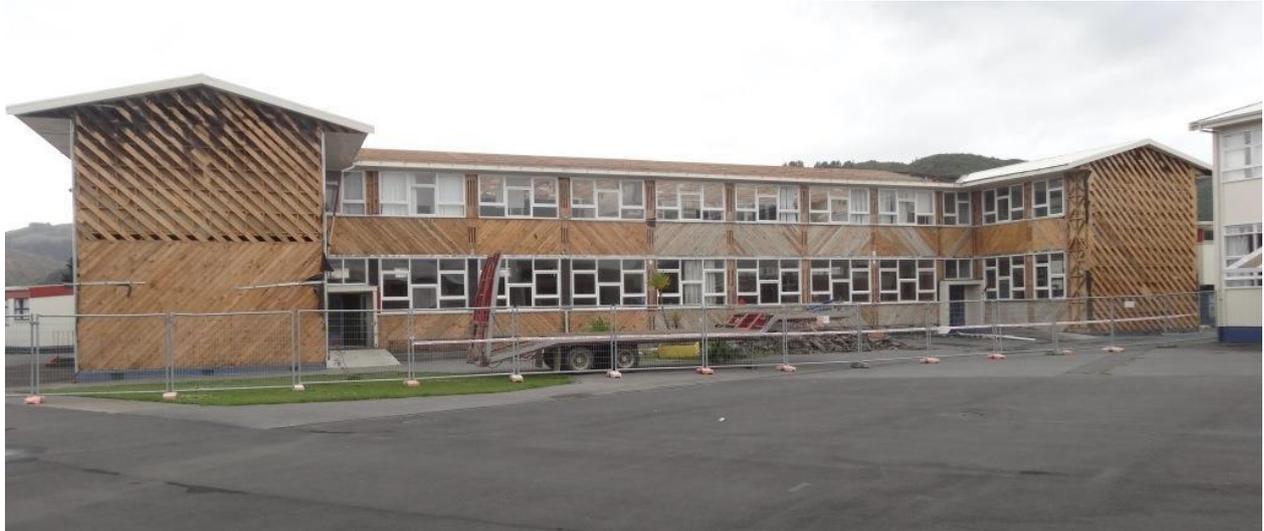
**Figure 8. Nelson block structural framing**

performance in the Canterbury earthquakes and knowledge gained from the other destructive tests outlined above, these structures are not at risk of collapse in strong ground shaking. Figure 8 shows the structural framing elements of the Upper Hutt College Nelson block following removal of the exterior cladding. This image also highlights the large footprint and hence low aspect ratio of these buildings.
